RE: Dove Pond Dam – Request for Inspection and Corrective Action Regarding Outlet Control Structures and Potential Seepage Impacts to State Conservation Lands Managed by Leon County

Subject: Report of April 28, 2026 Observations, Dove Pond, Tallahassee, Florida

Re: Dove Pond Dam
Site Inspection Report – Stormwater Management System
MBC #T0297.0084

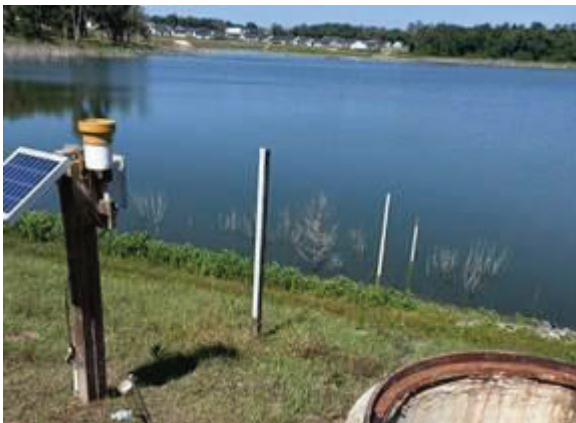
Staff Gauges

The water level at the time of this visit was approximately 87.6 feet above the project elevation datum, based on a staff gauge reading of 6.36 feet and prior correlation of staff gauge readings with the project elevation datum.

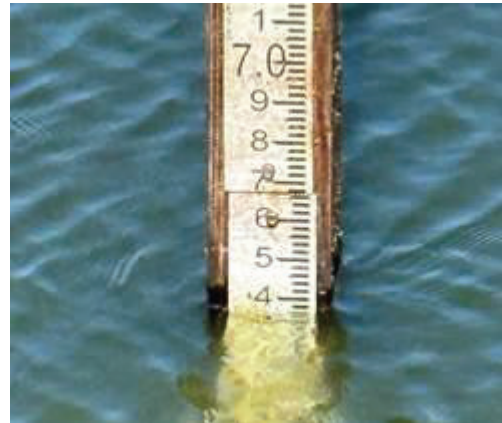
Water Level Reading = 6.36 feet

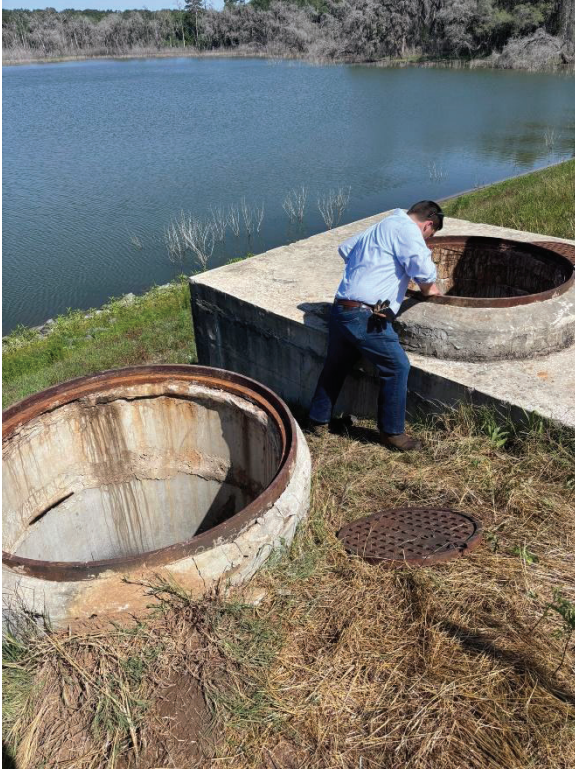
The vaults were opened and observed as shown below. The pipes and valves were exposed. The bottom of the circular vault with the float valve was only partially covered with water, while the rectangular vault with the 24-inch pipe valve vault bottom was covered with a few inches of water. We understand that the 6-inch valve for the float valve was closed. And, by observation, given the lack of flow downstream, the 24-inch valve was closed. No appreciable leakage into either vault was observed.

View of Vaults from Dam Crest

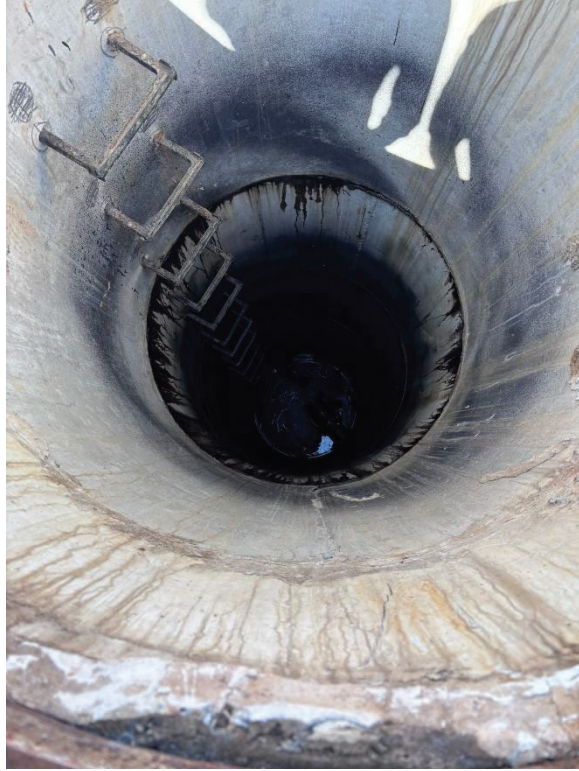
View of Vault for Float Valve

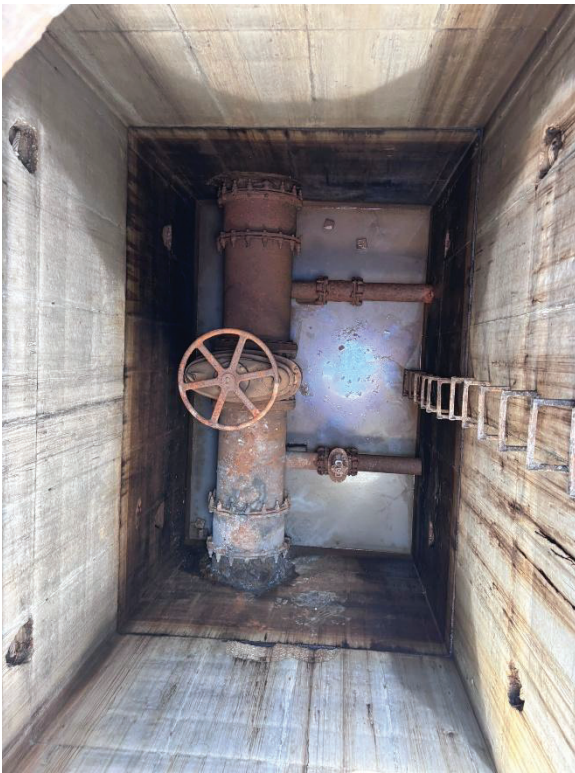
View of Vault for 24-inch Pipe Valve

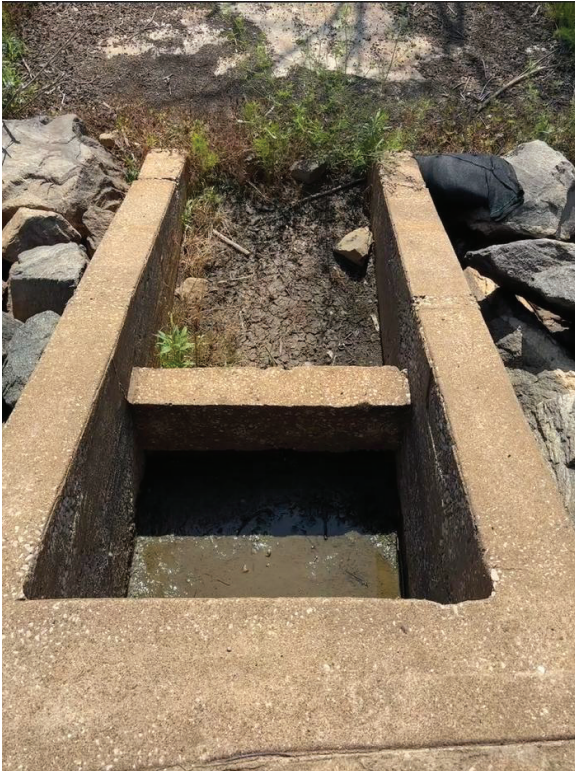
The outfall of the 24-inch pipe and the toe area of the dam were observed to be generally dry. The bottom of the pipe was wet, but there was no apparent flow. The soil at the base of the structure is partially wet and dry. See the photographs below.

View of 24-Inch Outfall Looking Downstream

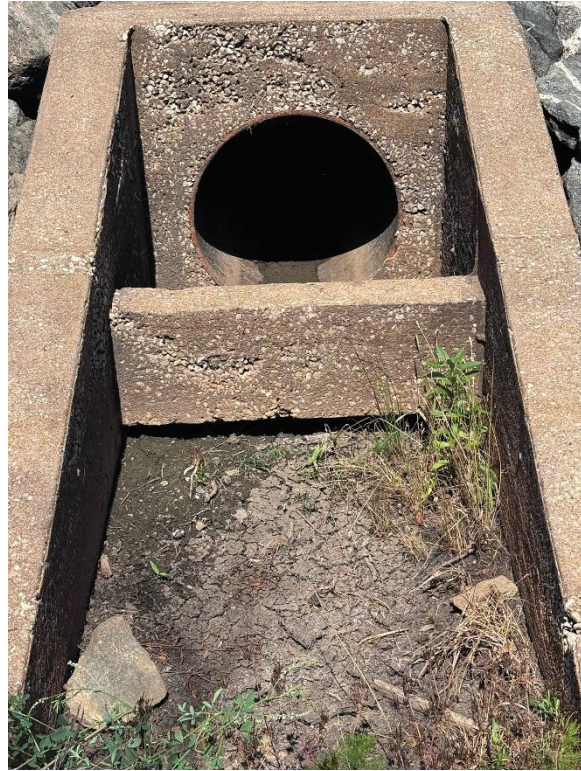
View of 24-Inch Outfall Looking Upstream

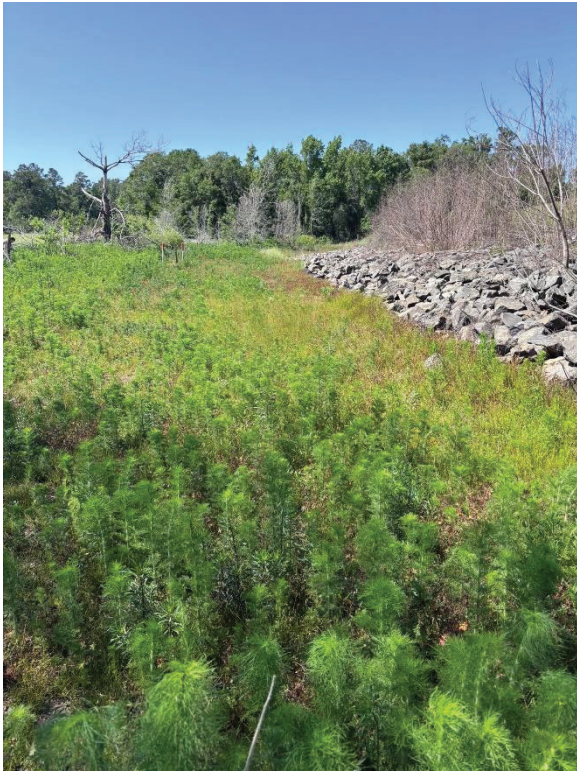
The downstream toe area beyond the armored slope was dry. No standing water or wet areas were apparent along the length of the toe. Note that the toe area was also observed to be dry in observations made on January 13, 2026, when the water level in Dove Pond was at approximately 90 feet. The soil in the toe area was desiccated, and some vegetation appeared stressed. The drought-tolerant seedling dogfennel is still green.

View along Downstream Toe Southwest of Outfall

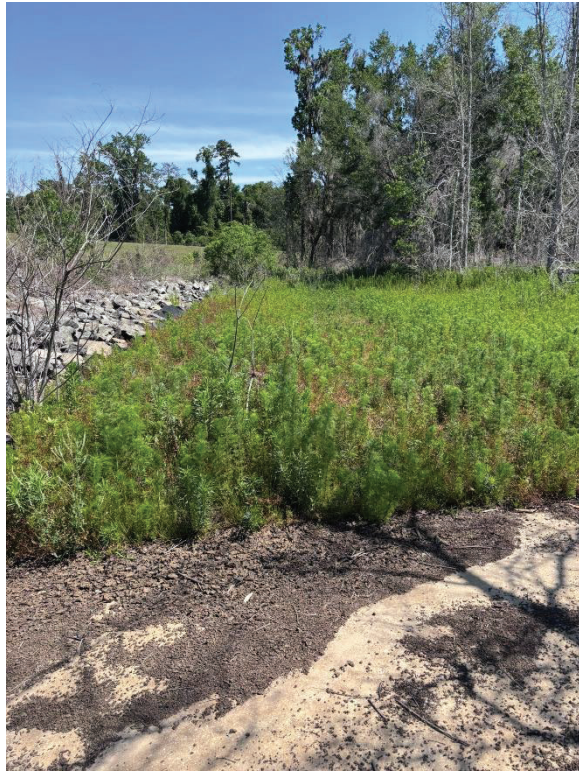
View along Downstream Toe Northeast of Outfall
