**Additional Information for Budget
Discussion Item #5
for Budget Workshop
June 21, 2022**

SUBJECT: Additional Information Requested on the Lake Hall School House

RE: Feasibility Study for the Relocation of The Lake Hall School

Existing Conditions Report

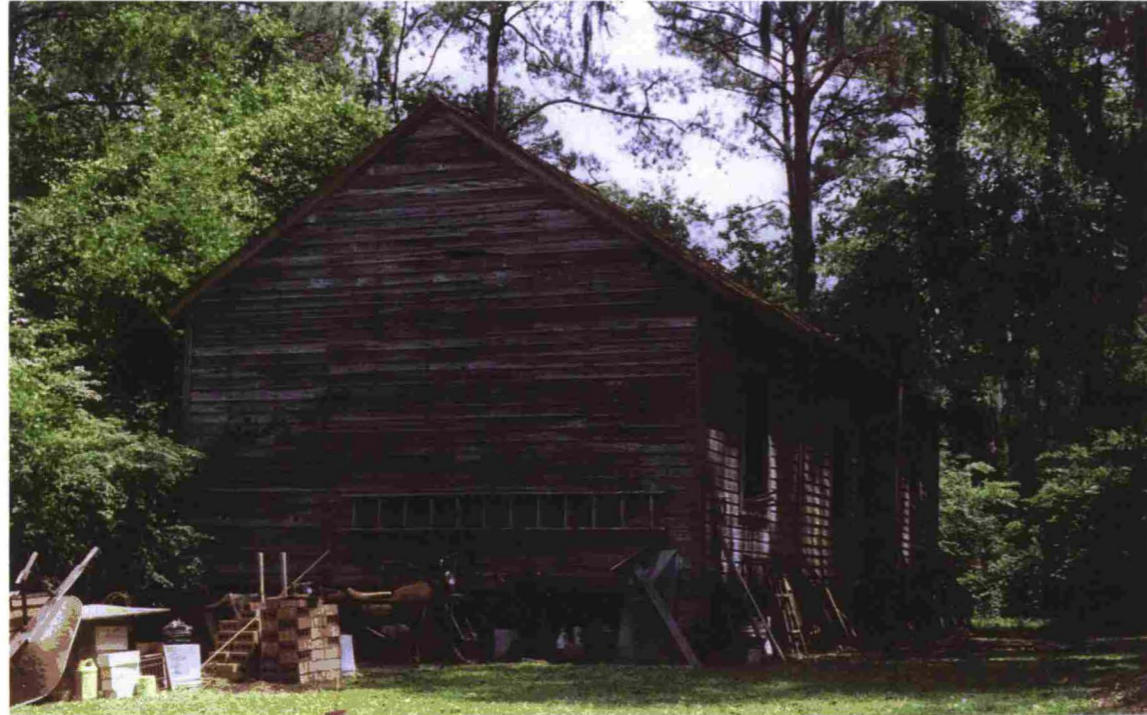
The Lake Hall School. Currently used as a Storage Building

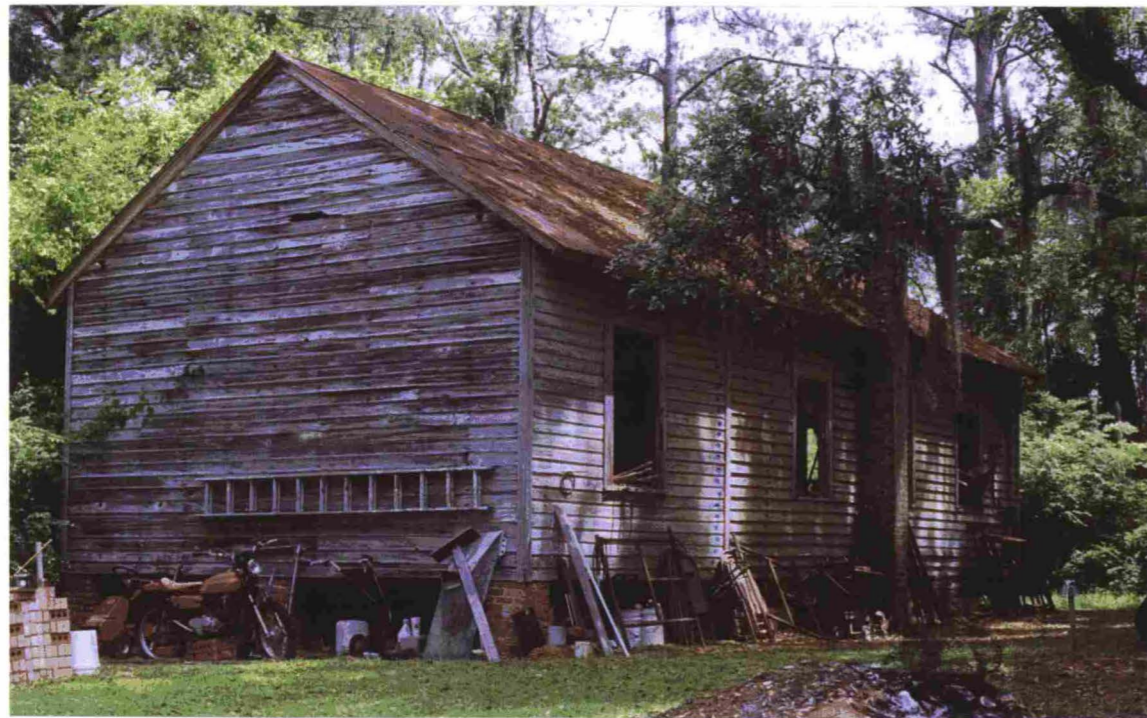
The Lake Hall School showing the Addition on west end and window fenestration pattern.

The structure has several interesting characteristics and clues as to its evolution. The most obvious and striking feature is the undated addition on the west end of the building. This later addition has several distinct differences, including the foundation, framing, siding and roof sheathing. See photos page 1.

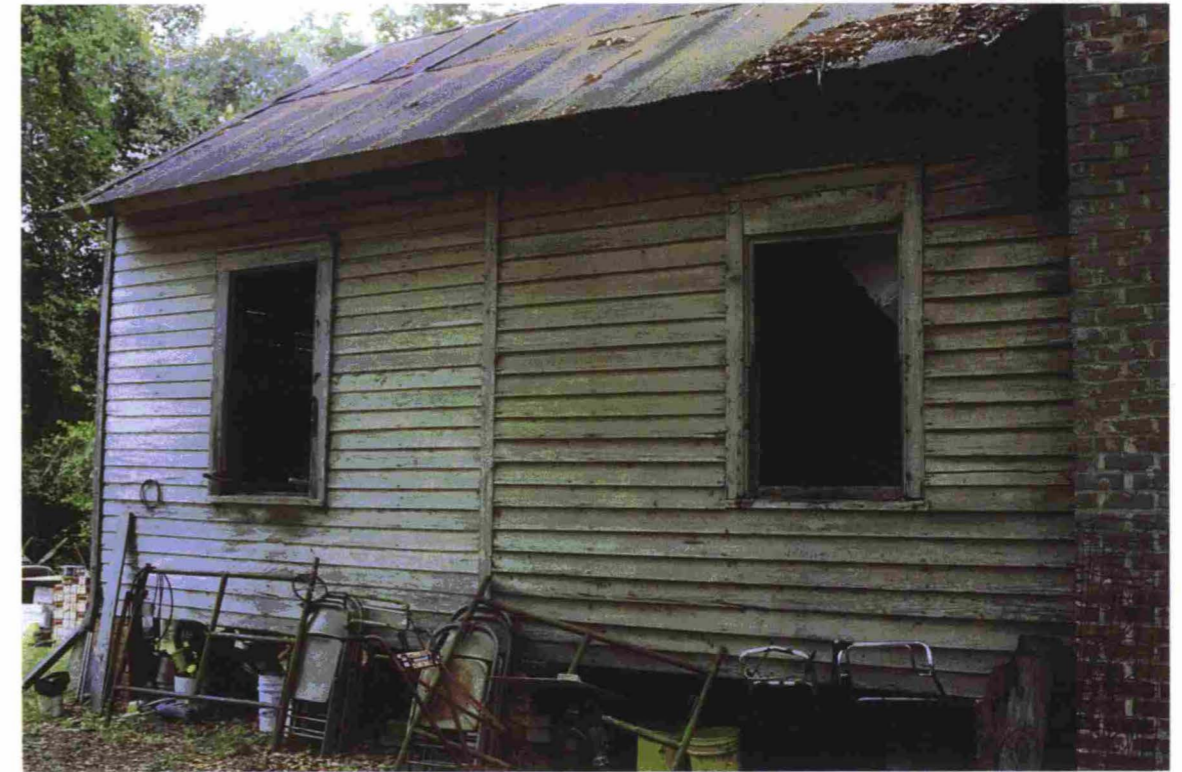
The Lake Hall School. View looking northwest, suspected addition and different siding materials.

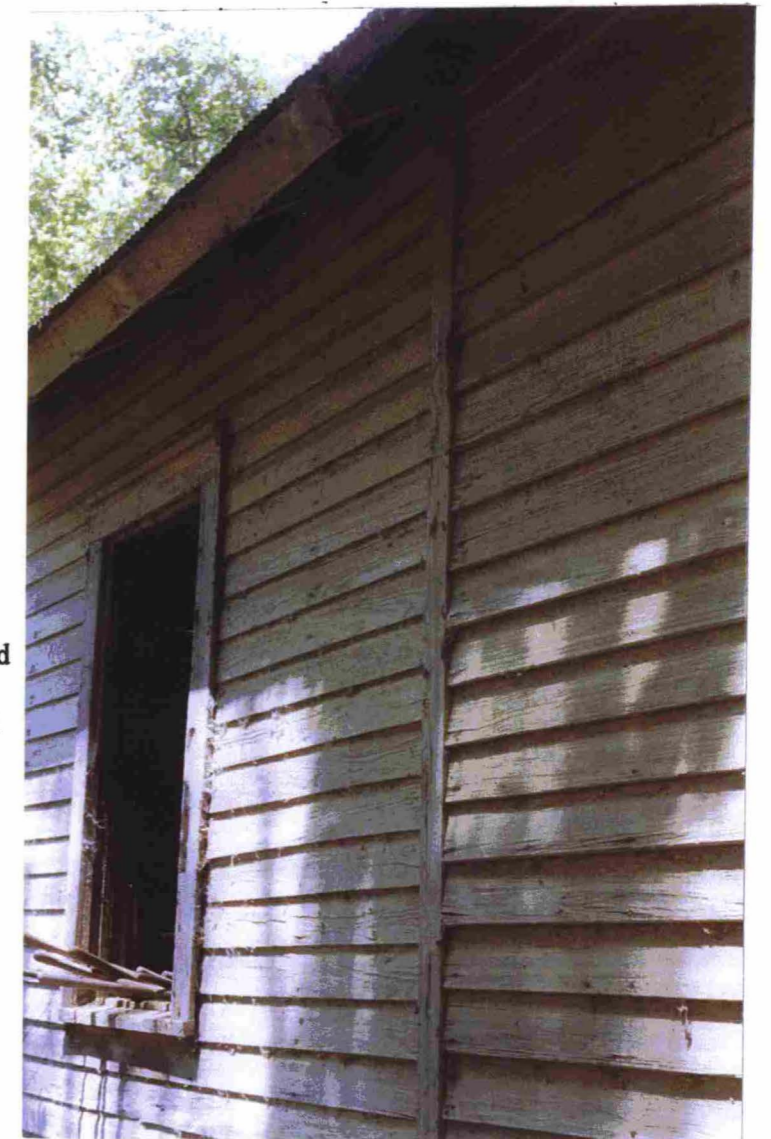
Close up of siding and seam between the original structure and the suspected (undated) later addition. Note the change in the siding material and spacing. Also, note the change in roof fascia detail.

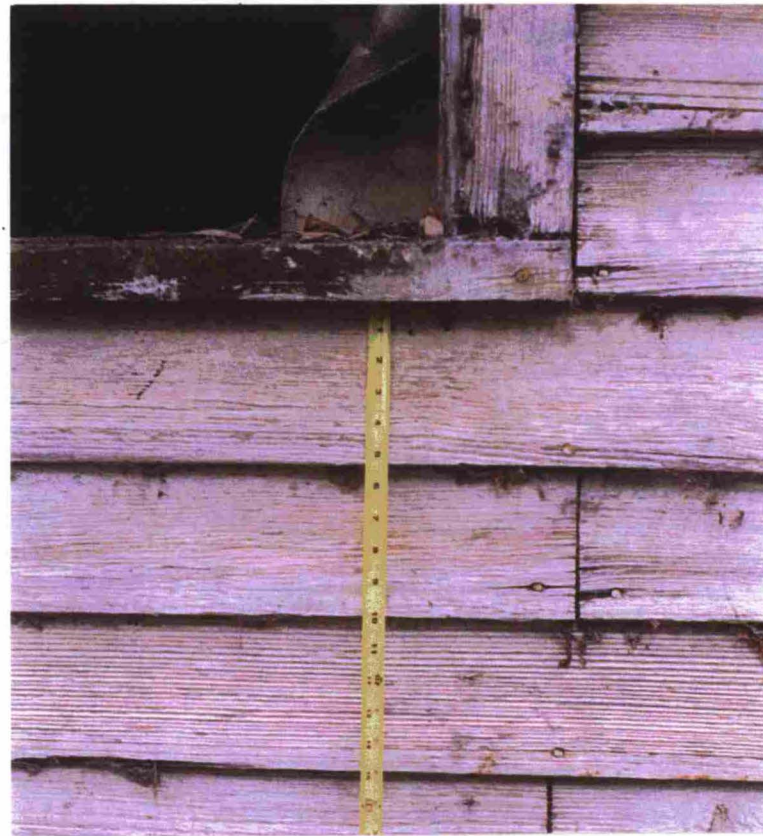
The beveled siding on the main or "original" portion of the Lake Hall School. Measurement is 6" with 5" exposure.

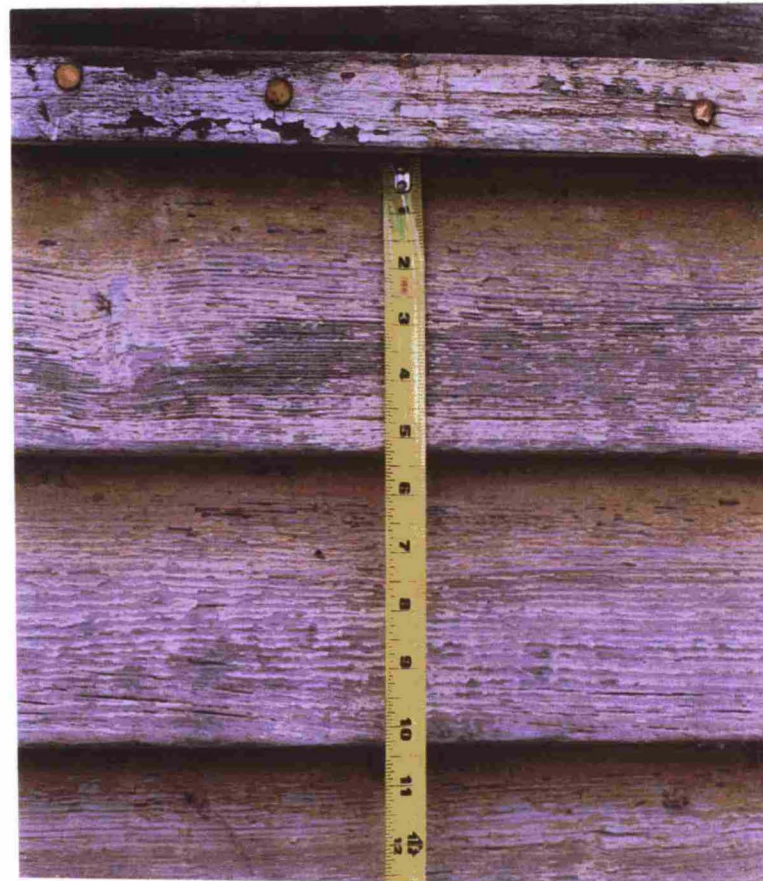
The "drop" siding on the suspected (undated) addition of the Lake Hall School. Measurement is 6" with 5-1/4" exposure.

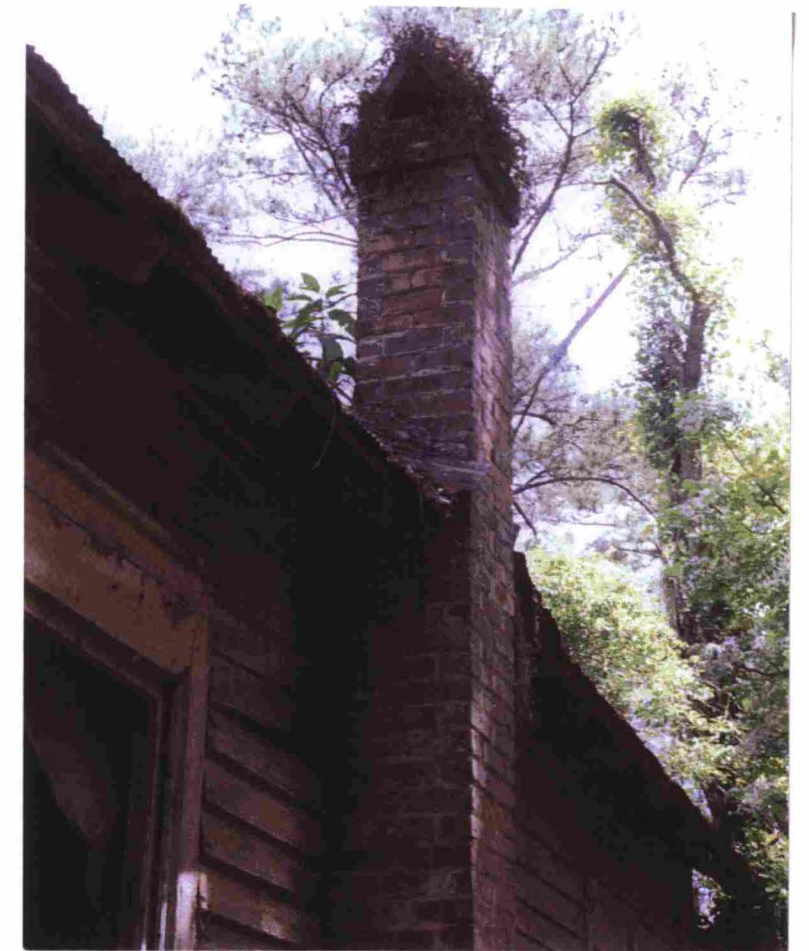
The Lake Hall School. Chimney detail. Clay pipe flue enters building 7 feet above floor. Metal wood burning stove mentioned in oral history accounts is no longer present.

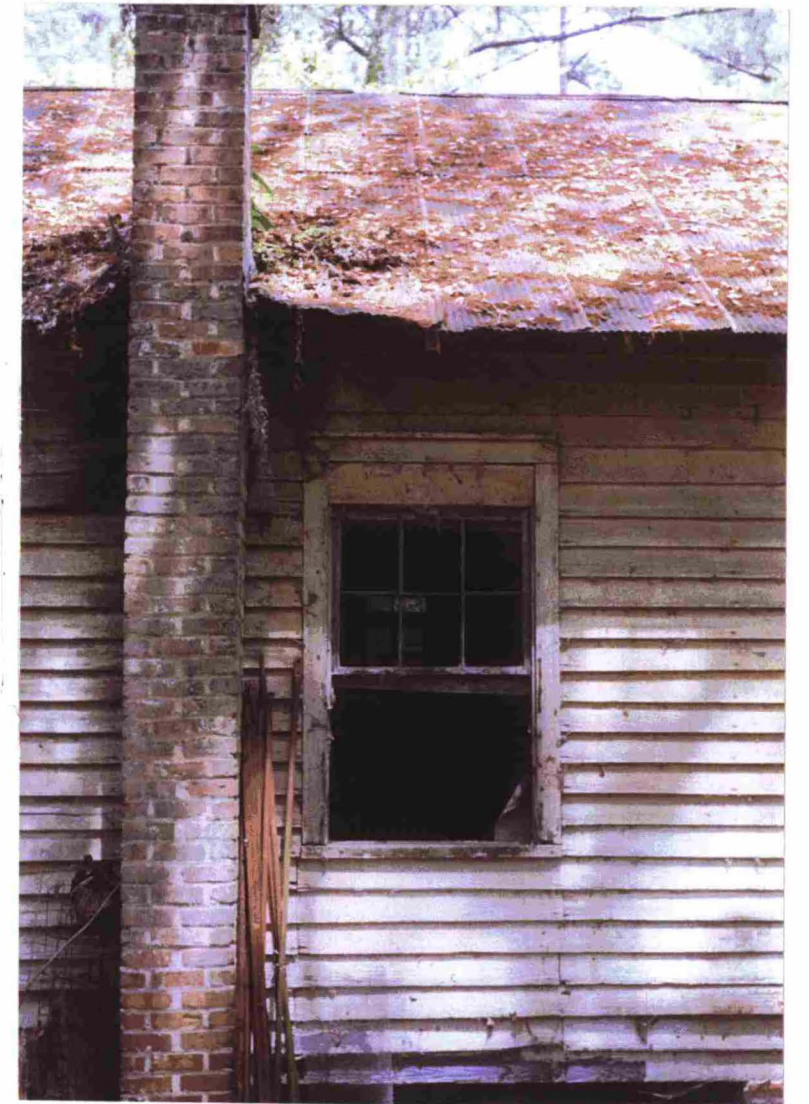
Chimney and adjacent window on south elevation. Note, common framing blocking at top of window. Former proportions indicate original window size. Sashes present in the openings are replacements and do not match the original sash dimensions.

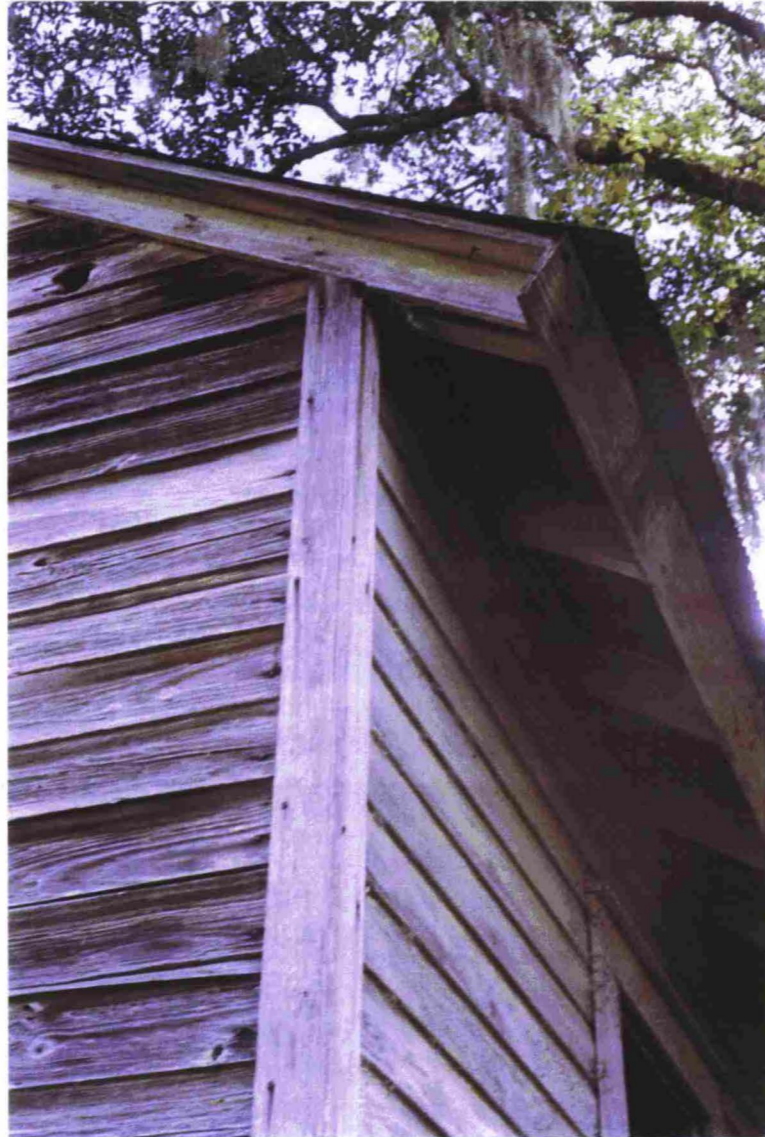
Corner trim at addition.
Southwest corner of building.

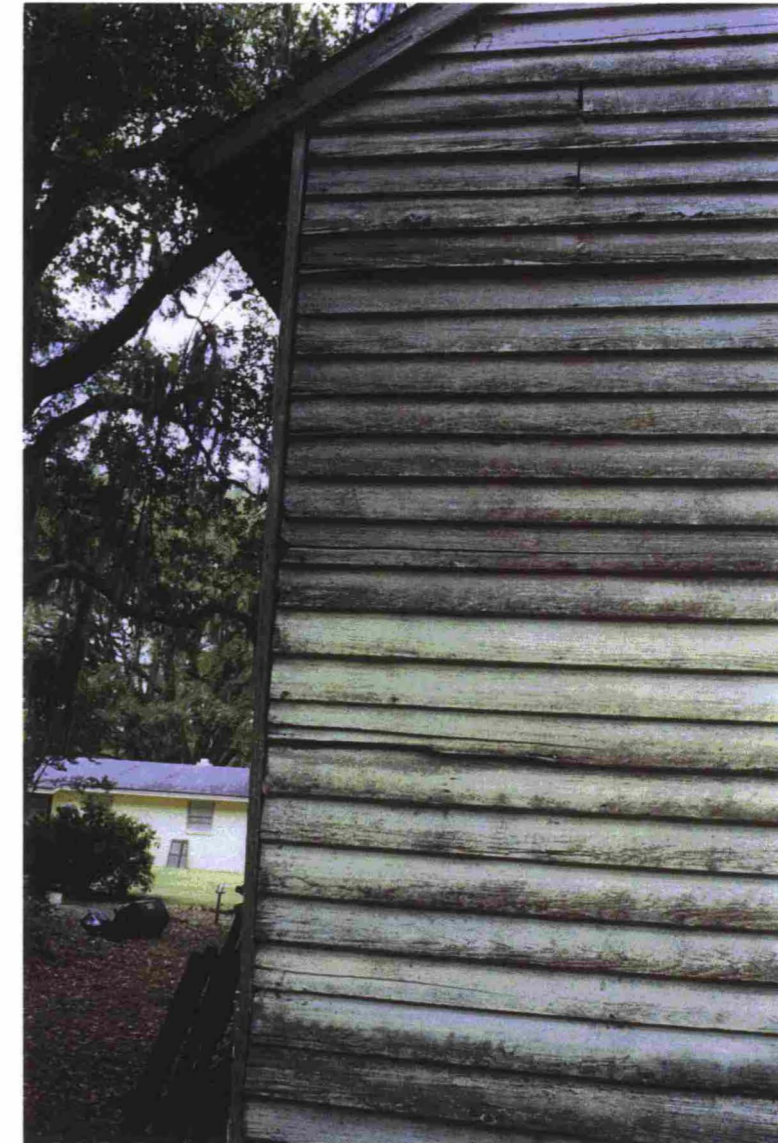
Simple trim condition at
corner of "original" Lake
Hall School.
Southeast corner of building.

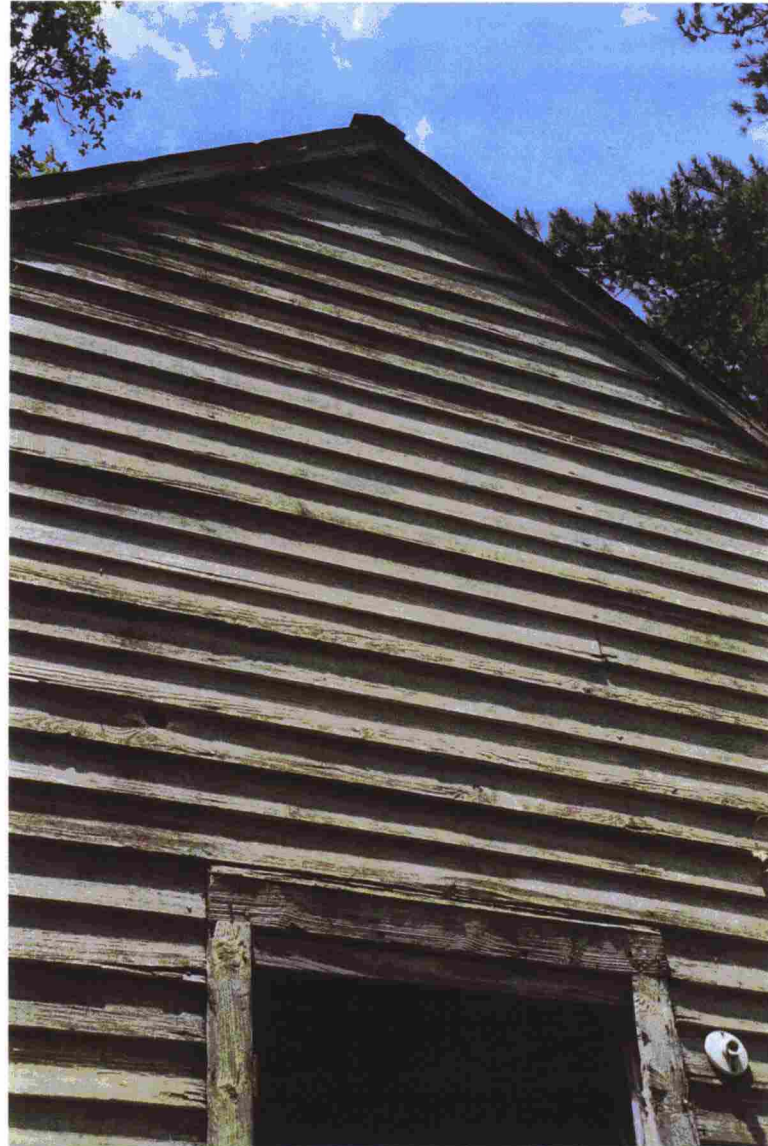
East gable of Lake Hall School.
Note gable end and door detail.

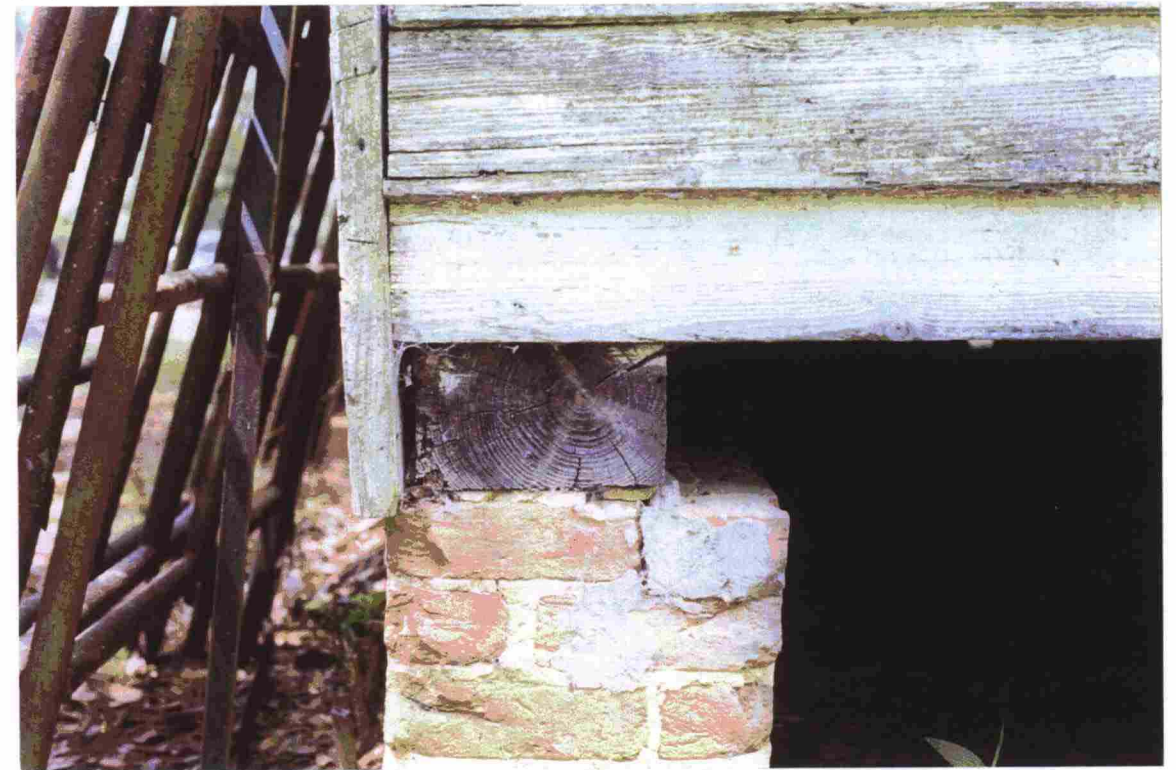
Southeast corner of original structure.
Note 6"x 8" perimeter beam set with
the 8" dimension bearing. Perimeter
beams are typically set with the short
dimension down. Notched joists
run perpendicular.

The beams are laid on their wide dimension so that the 6" dimension is spanning the distance between the brick piers. The floor framing is actual 2"x 8' floor joists at 24" on center. The perimeter bear on the east end beneath the main door is severely deteriorated. A portion on the north side of the center beam has been repaired with common framing lumber and additional rot and damage has occurred to that wood. See photos page 4.

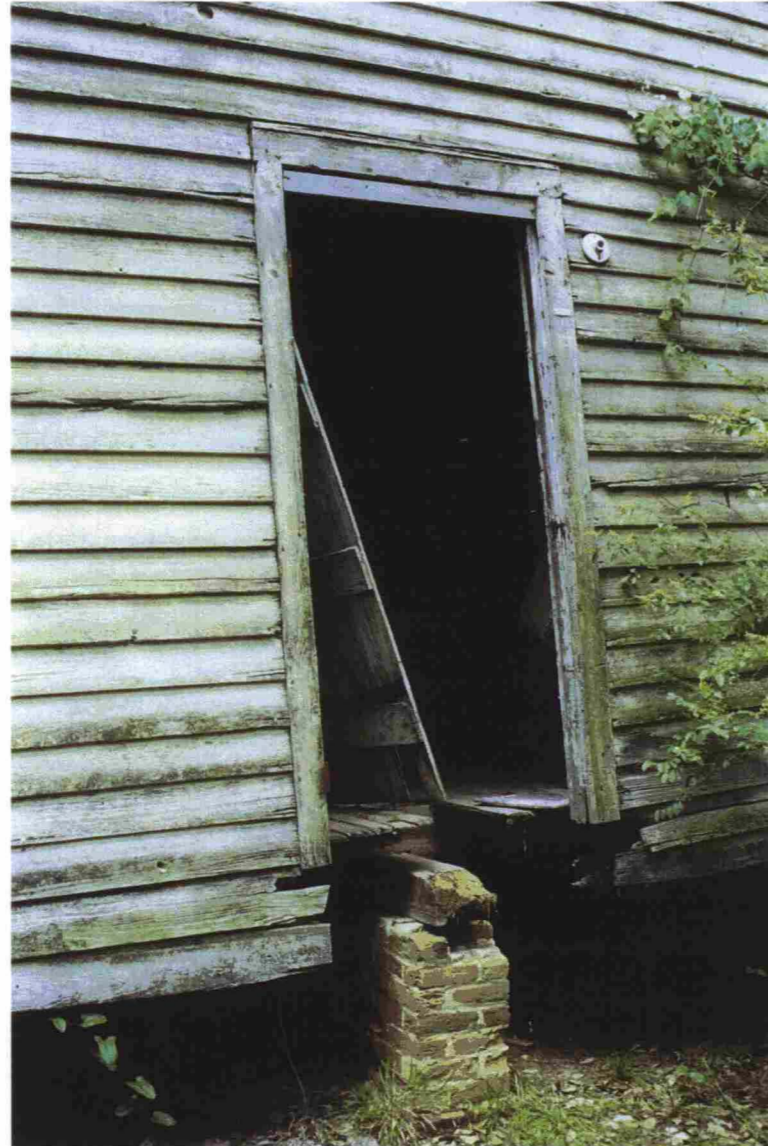
The Lake Hall School.
Primary entry door.
Note door in opening,
no longer attached to
frame. Severe deterioration
present at perimeter frame
in north-south direction.
Stairs once located here
Have been removed.

The purported original door exists, off its hinges just inside the doorway. It is a common butted plank on a cross frame with a hollow metal cast knob. Hinges and knob set are severely rusted and is also not likely original to the structure due to their craftsmanship and apparent age.

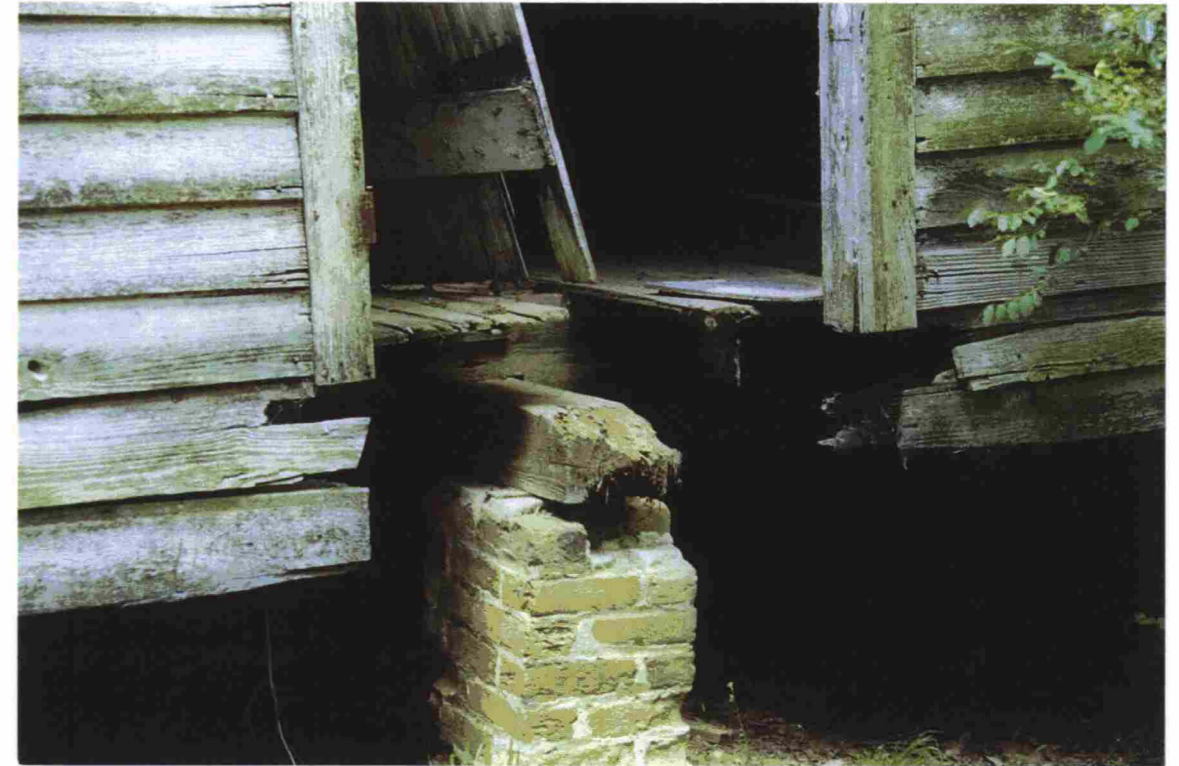
Close up view of former school entrance and deteriorated perimeter
beam. Note original pier form and construction. Door and window
frame details and construction clearly discernable.

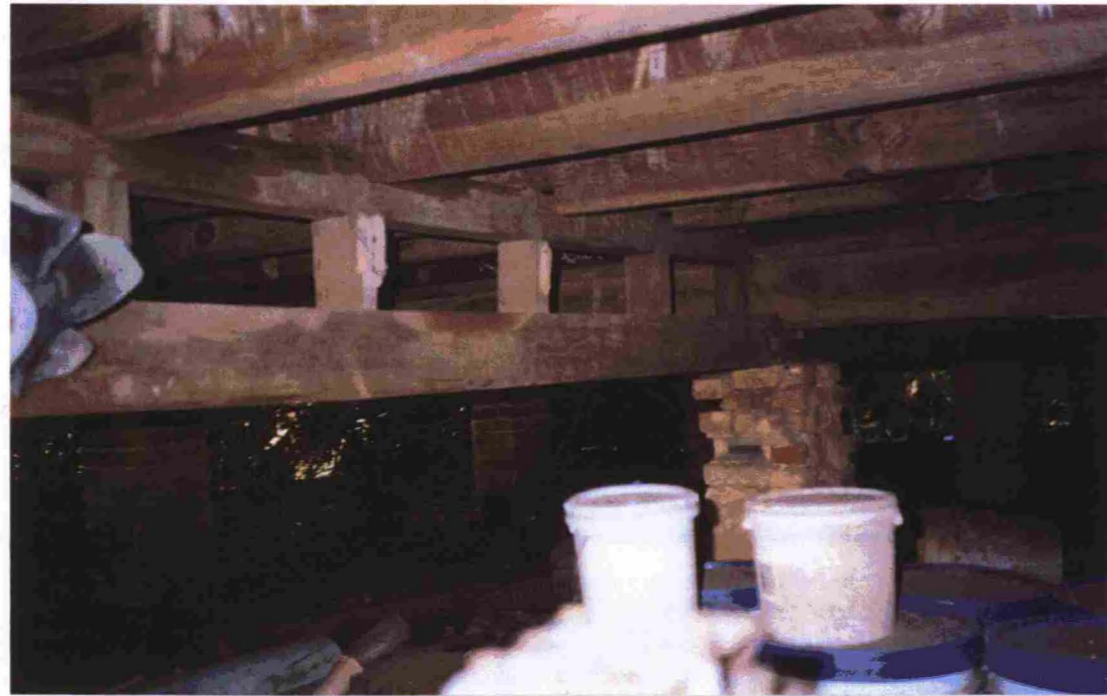
The extended center beam under the west end addition to the Lake Hall School..

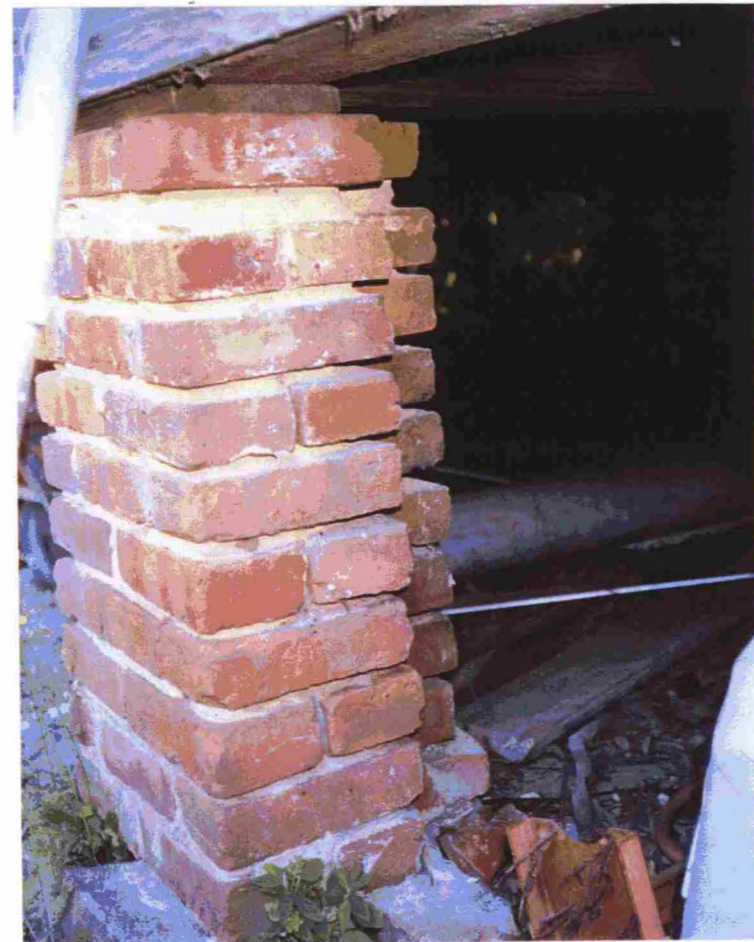
A shaped pier at northwest corner of Lake Hall School. The pier at the southwest corner is the same, opposite hand.

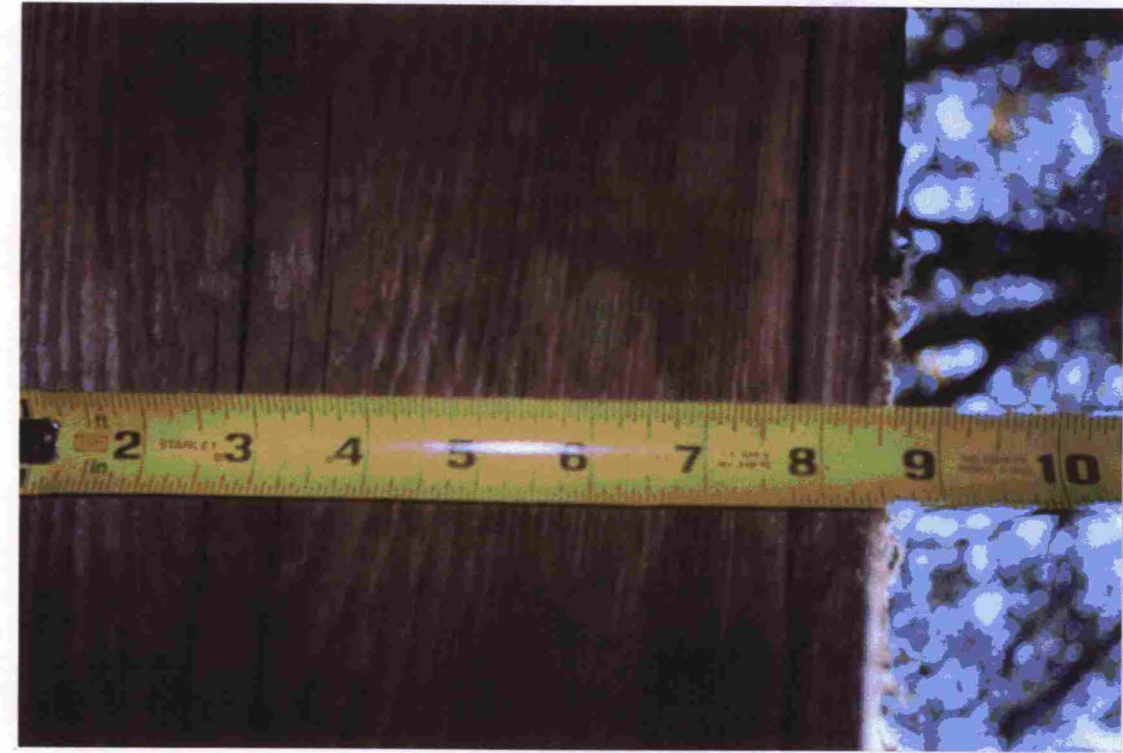
Photo of perimeter beam, dimension in flat dimension from under the school.

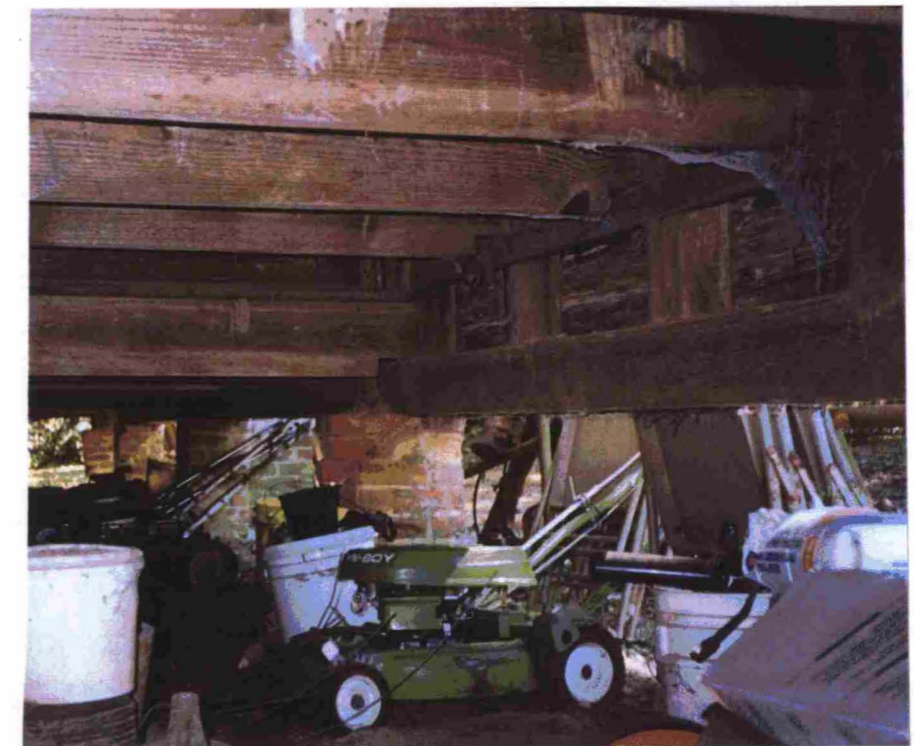
Photo of perimeter at addition on west end. Lower beam is the extension of original school. This provides platform raised above former level of school.

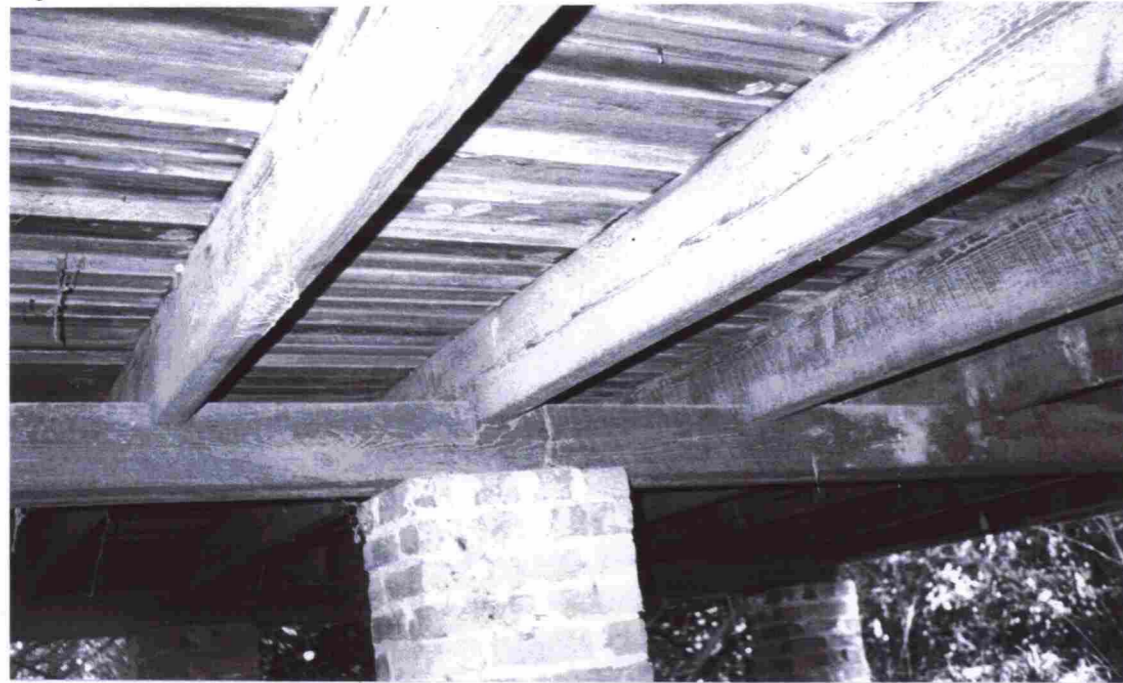
The Lake Hall School. Typical floor framing under original school.

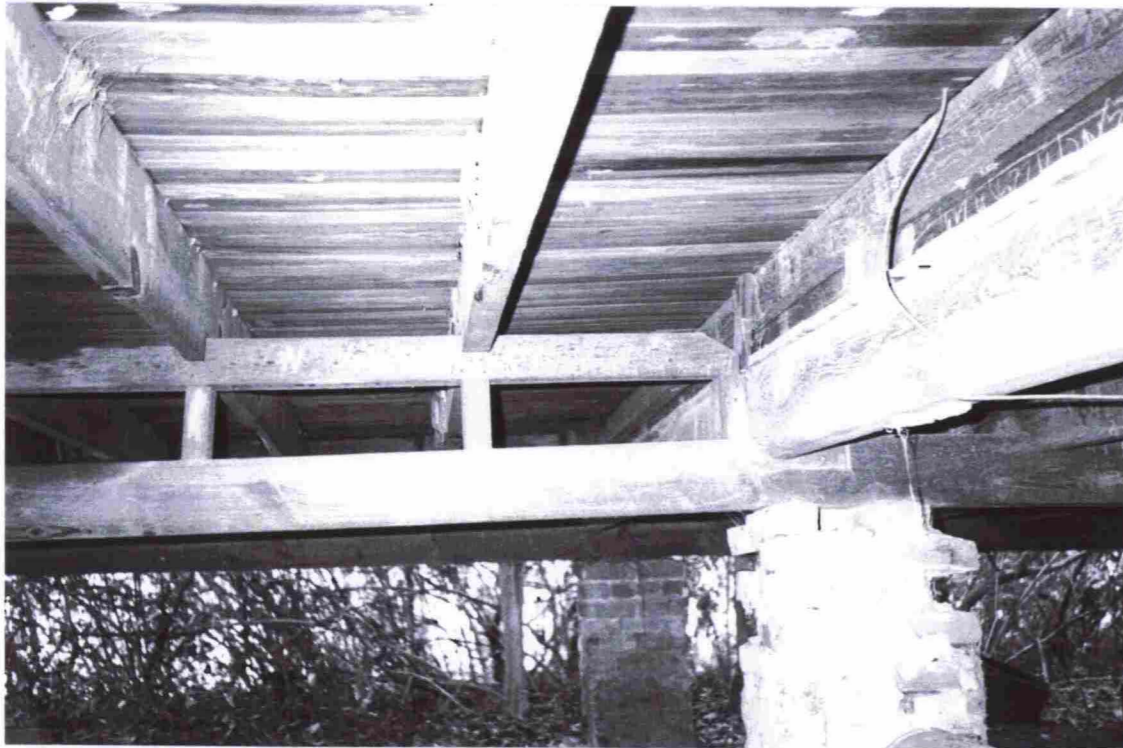
Floor framing under addition on west end of school..

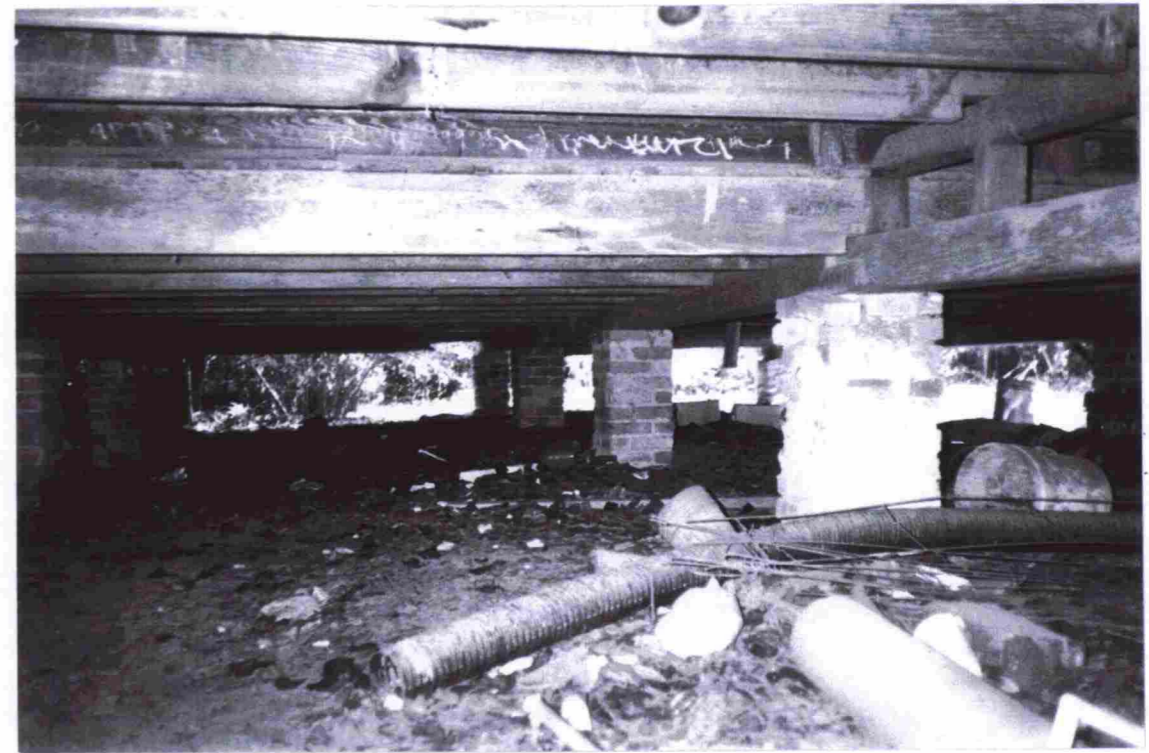
Floor framing at the center pier at intersection of original structure and addition.

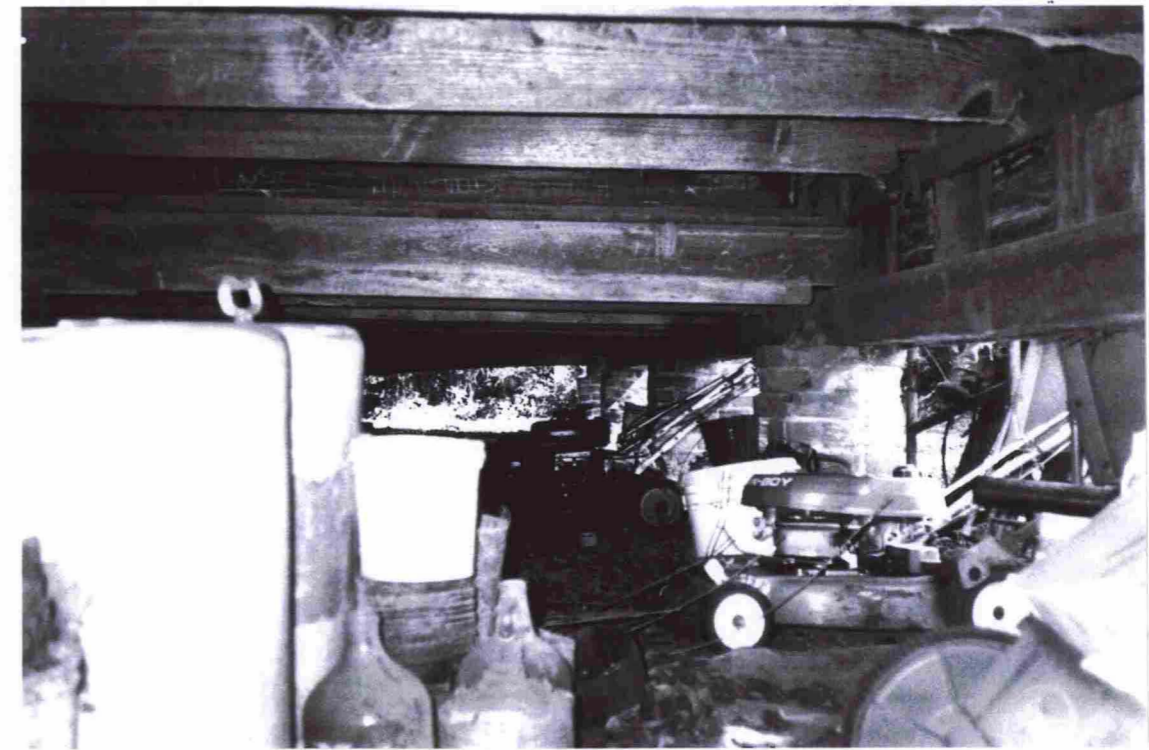
Perimeter of structure on south side at intersection of original structure and addition

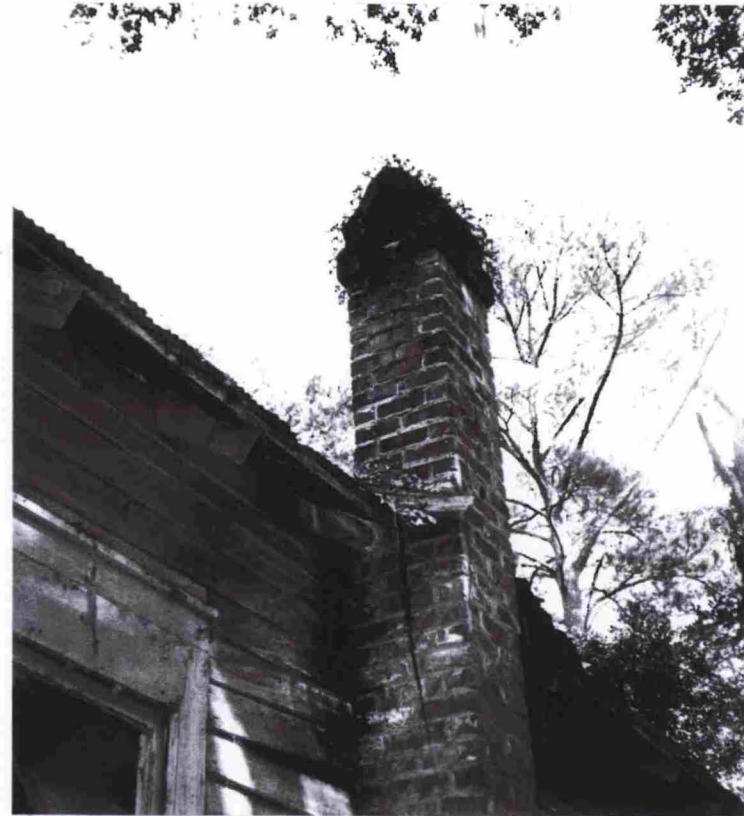
The articulated arched chimney interface at roof.

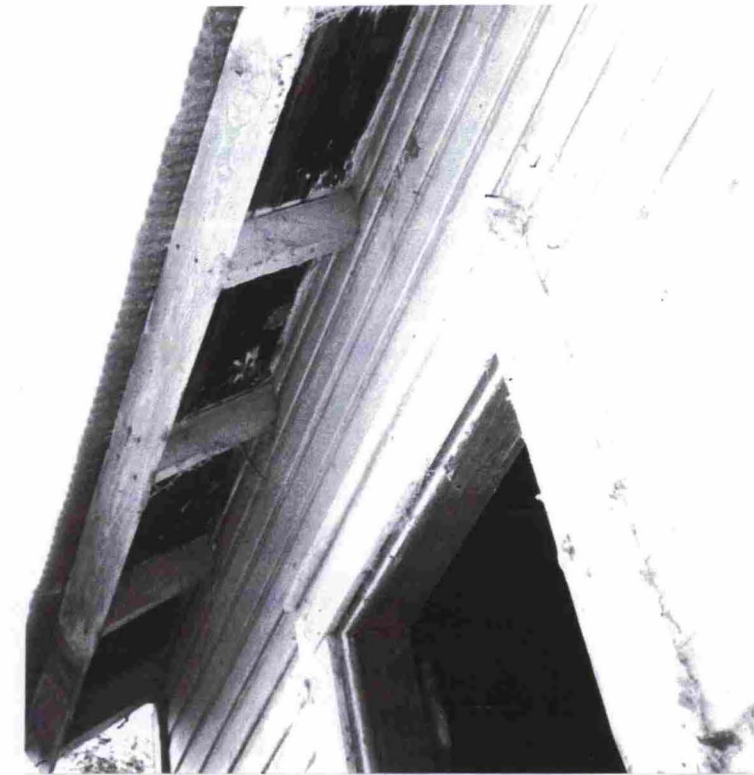
The roof rafter end detail at the addition on west end of schoolhouse.

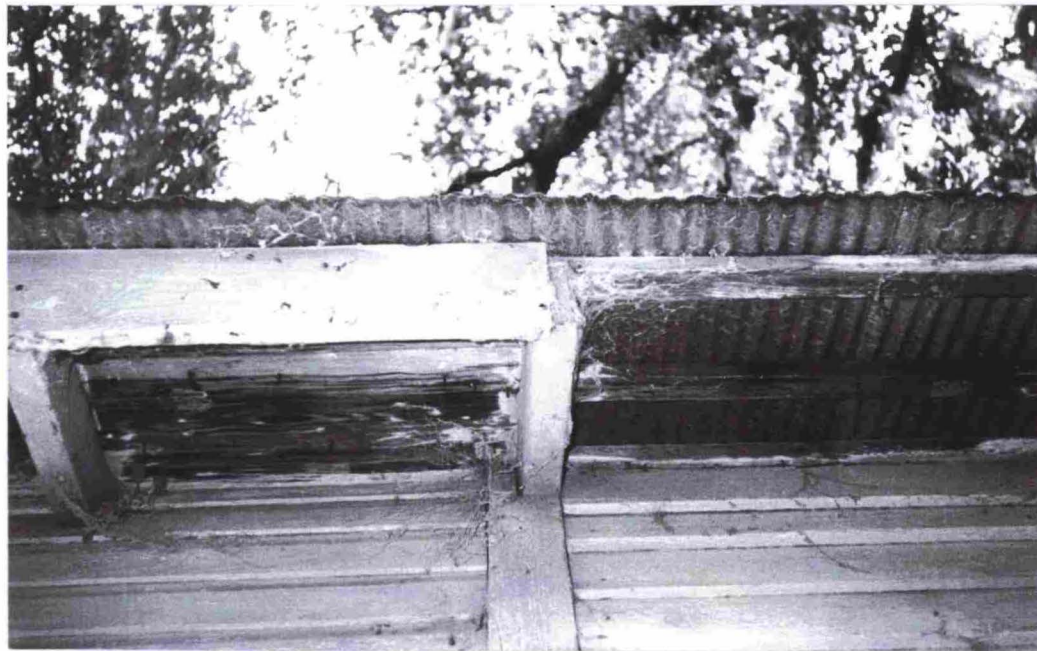
The change in roof sheathing and framing between original and addition. Note the roof is sheathed at the addition and uses purlins at the original. This suggests a different roof material was also used on the original.

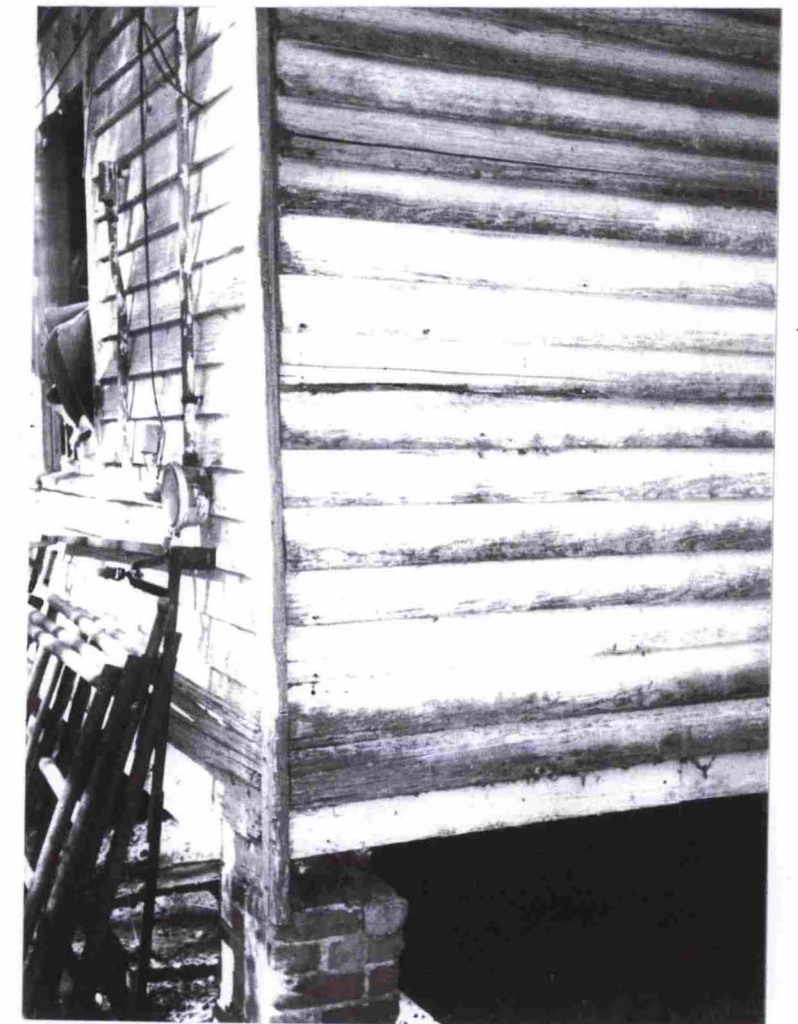
Electrical meter suggests the building had electric lighting.

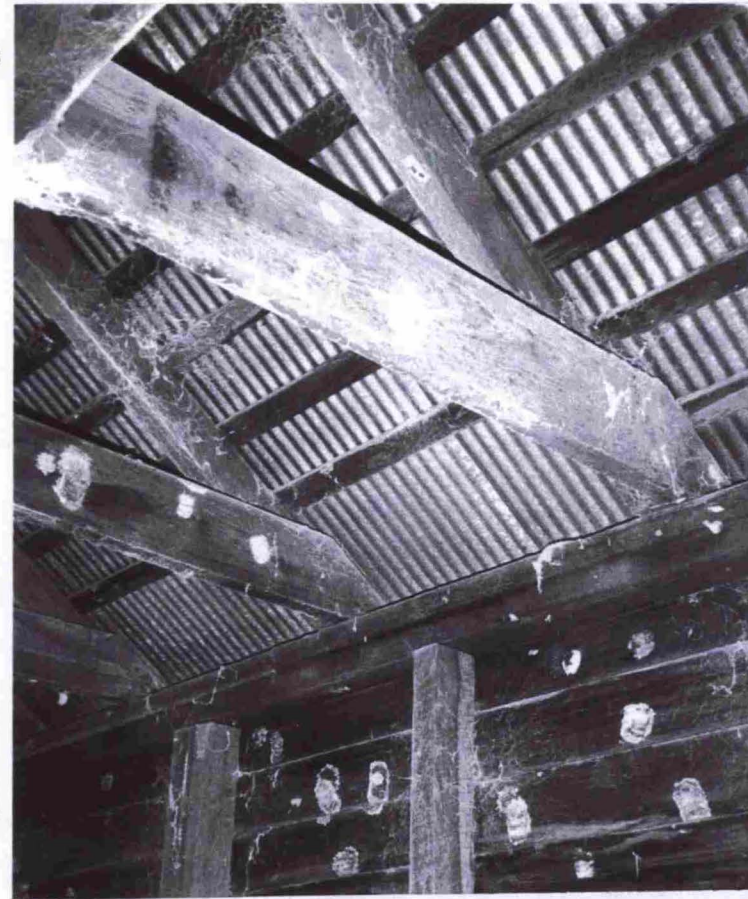
Interior of underside of roof framing in original structure. Note purlins and tie rafters. Also note 4"x4" top plate with 1" x 2" flat trim to finish ceiling.
