**Additional Information for Budget
Discussion Item #5
for Budget Workshop
June 21, 2022**

SUBJECT: Additional Information Requested on the Lake Hall School House

RE: Feasibility Study for the Relocation of The Lake Hall School

Existing Conditions Report

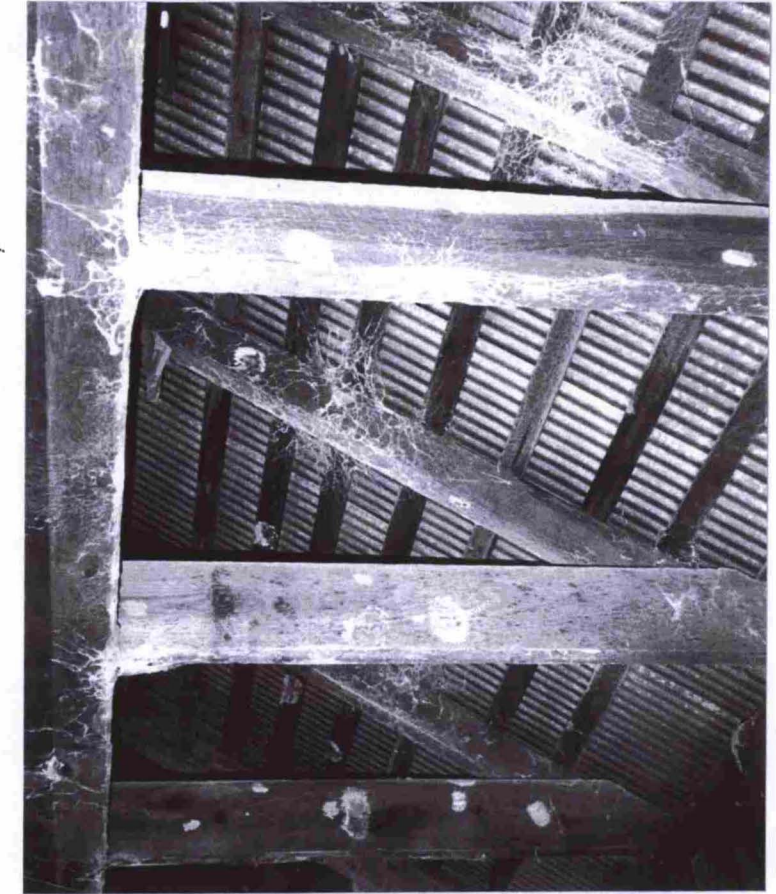
Another view of roof and remaining wood ceiling.

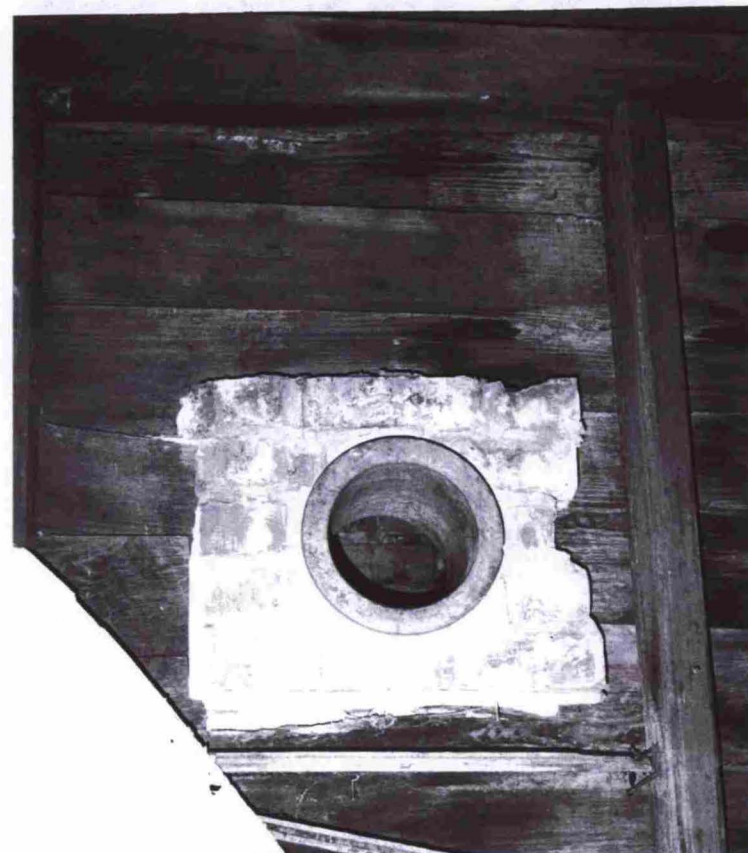
Clay pipe flue for wood burning metal stove.

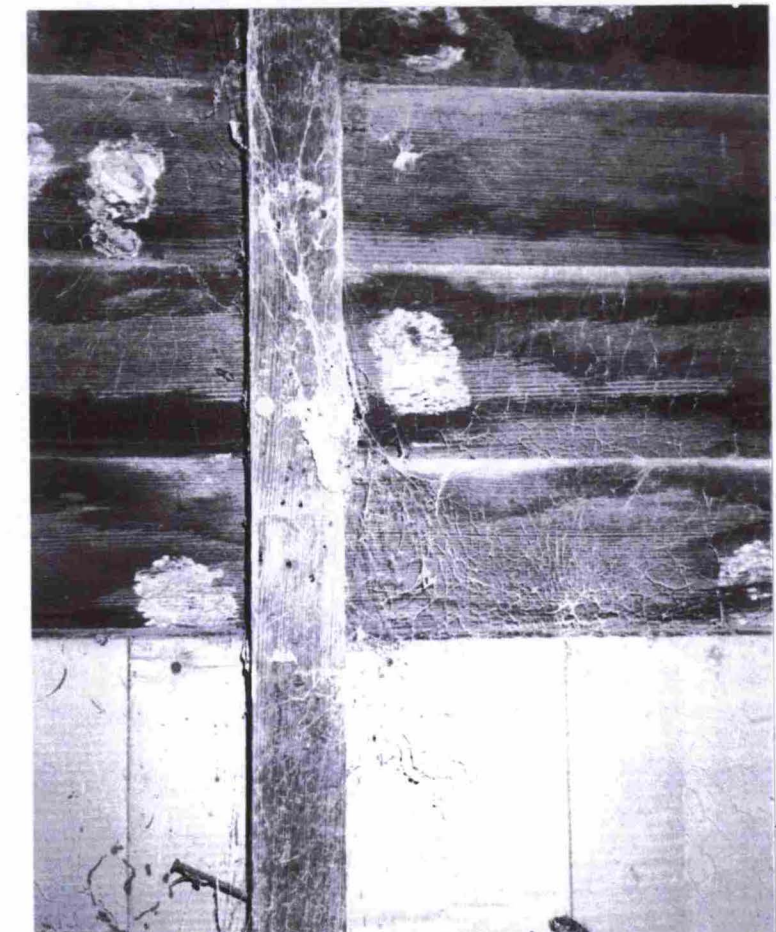
The Lake Hall School. Interior walls have regular nail pattern indicating some interior wall finish.
