CRTPA RETREAT

RETREAT AGENDA ITEM
CRTPA CORRIDOR REPORTS

CRTPA
TRAFFIC AND OPERATIONS ANALYSIS
THARPE STREET

DRAFT RECOMMENDATIONS

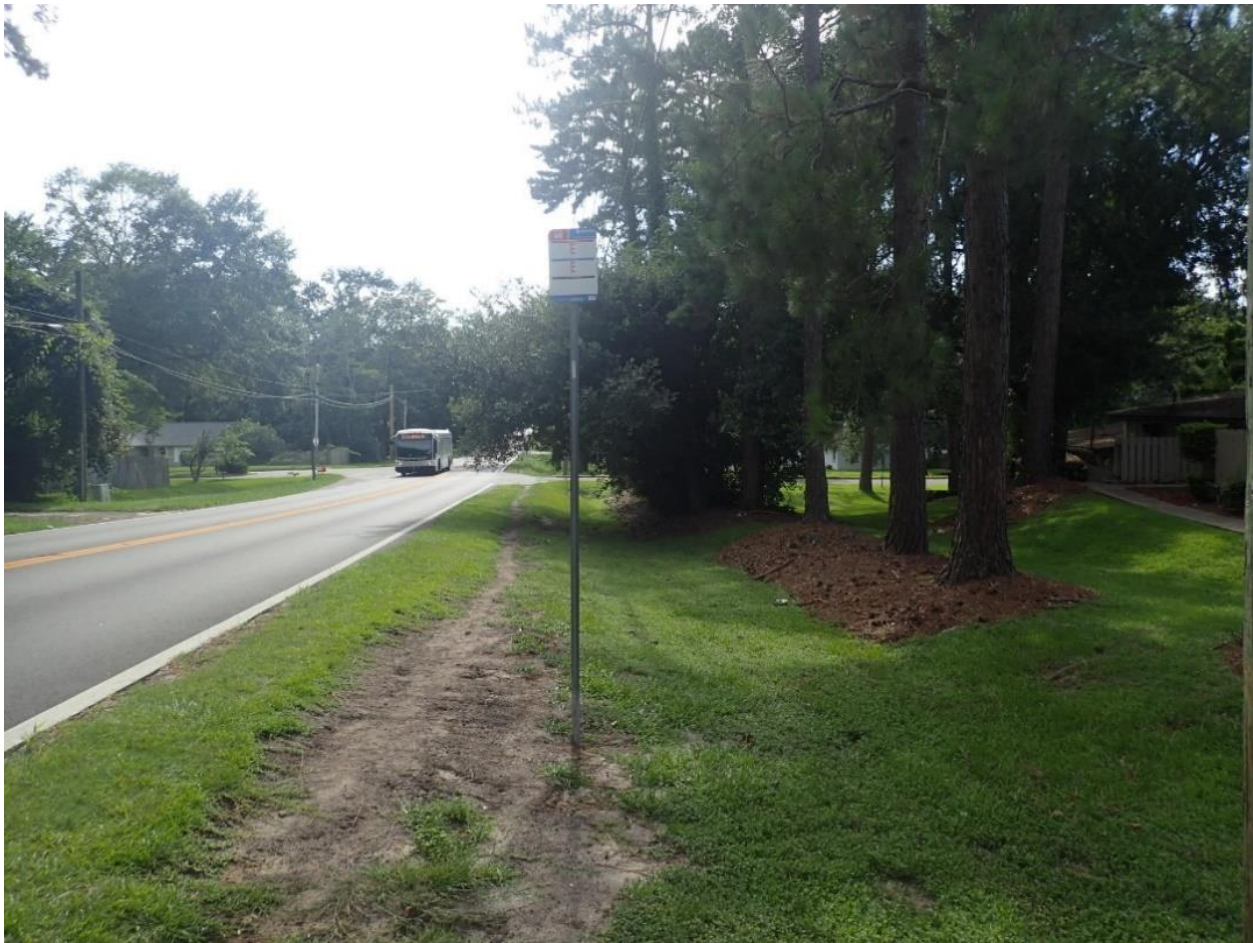
Figure 2. Typical Bus Stop Along Tharpe Street

StarMetro serves as the public bus service for the City of Tallahassee and Florida State University. Currently, bus stops along Tharpe Street are not compliant with the Americans with Disabilities Act (ADA) and offer limited information to passengers (see **Figure 2**). Current ADA compliance is only required when bus shelters and sidewalks already exist. StarMetro desires to make all public transit links adhere to current ADA standards, making the system more accessible and safe for all riders. In addition, bus schedules and route maps should be available to riders at all stops.

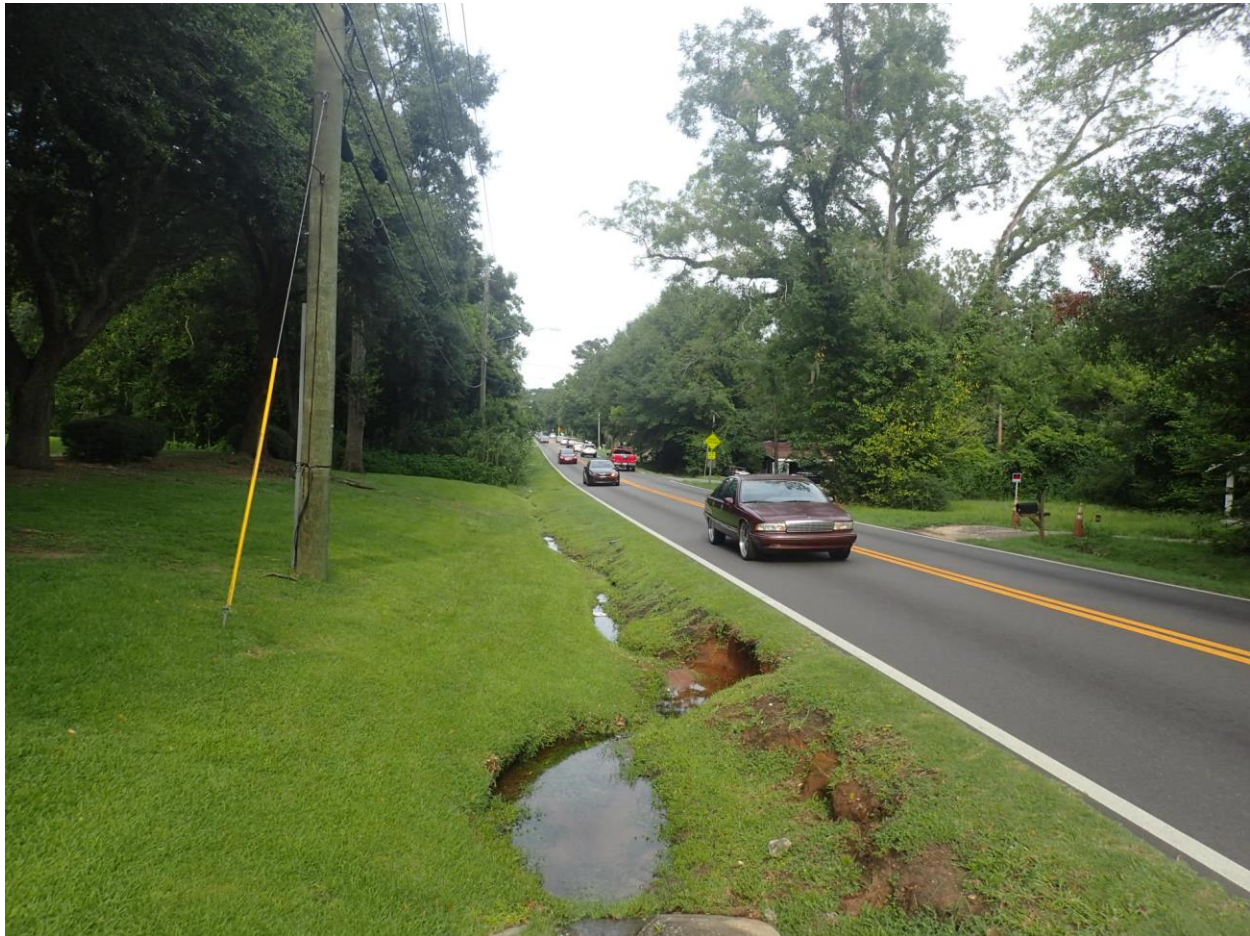
Figure 8. Slope Erosion Caused By Stormwater Runoff along Tharpe Street

Evidence of roadside erosion can be observed throughout the corridor. Existing conditions show roadway drainage traveling to nearby roadside ditches that transports water runoff to the nearest outfall point (see **Figure 8**). Presently, no stormwater treatment is provided for the roadway other than the flow time in grassed ditches.

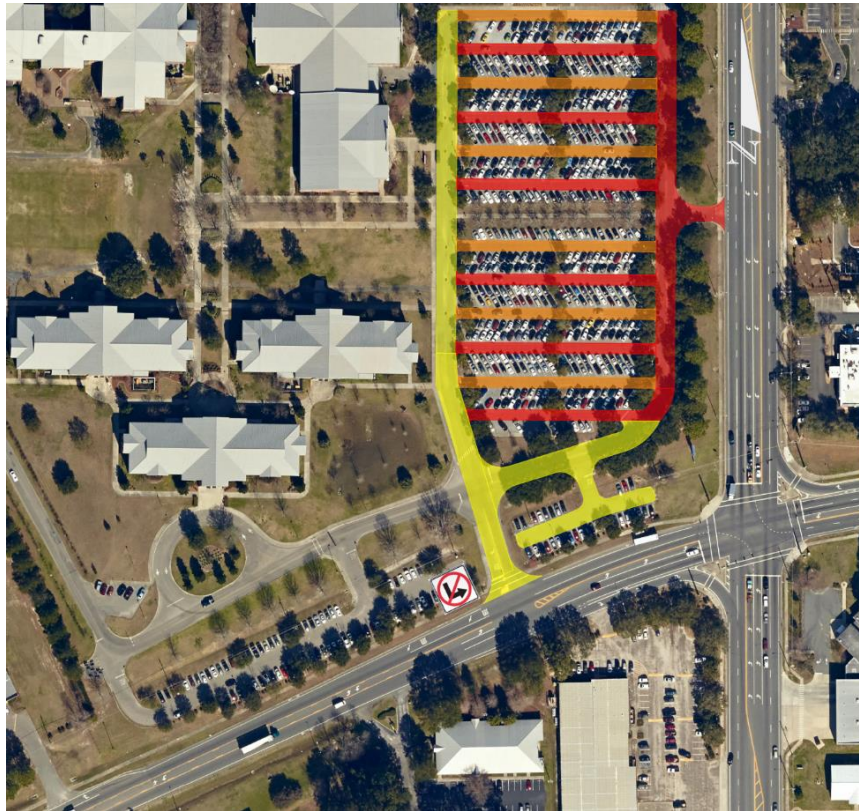
Figure 2. Typical Congestion from TCC Campus

Field observations report uniform dismissal from classes at Tallahassee Community College (TCC) as the primary cause of congestion along the corridor. The result is a short term spike in traffic as students and faculty begin to exit the TCC parking lot. As congestion worsens internally, motorists tend to follow a “path of least resistance” strategy.

Figure 2 above illustrates typical congestion conditions from high (red) to low (yellow). Field observations report drivers located in the southeast – Learning Commons - parking lot egress exit to the south onto Pensacola Street. Left turn movements are restricted at this location due to its proximity to the intersection at West Pensacola Street and Appleyard Drive. Despite left turn restrictions, motorists often make illegal left turns, crossing double yellow lane lines in U-turn maneuvers, utilizing private driveways to turn around. These traffic patterns exacerbate spot congestion during AM/PM peak hours.

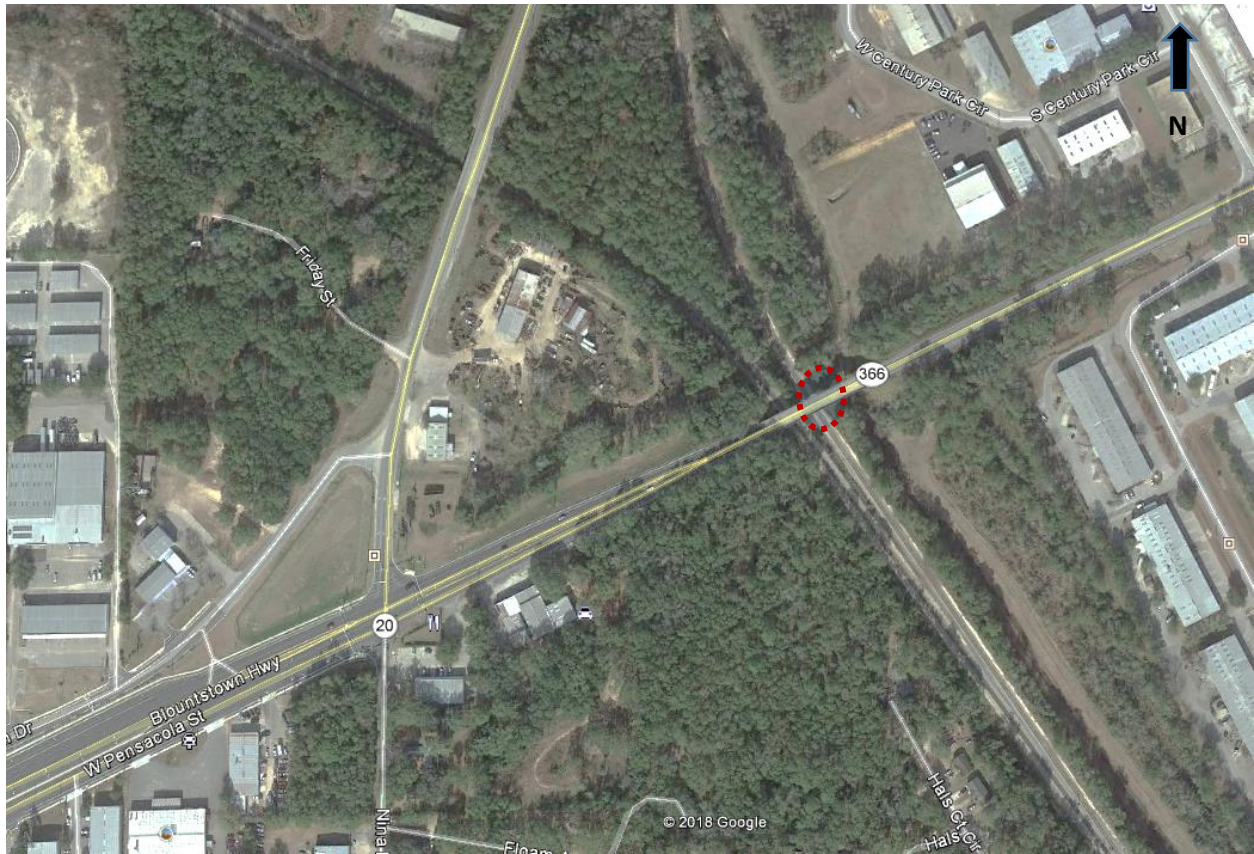
Figure 3. Bottleneck along Pensacola Street

Increased east bound traffic volumes are likely to occur due to the increased capacity of the 6-lane section of Pensacola Street. Furthermore, increase in traffic volumes would intensify congestion along Pensacola Street. For this purpose, the existing bottleneck is a candidate for remediation.

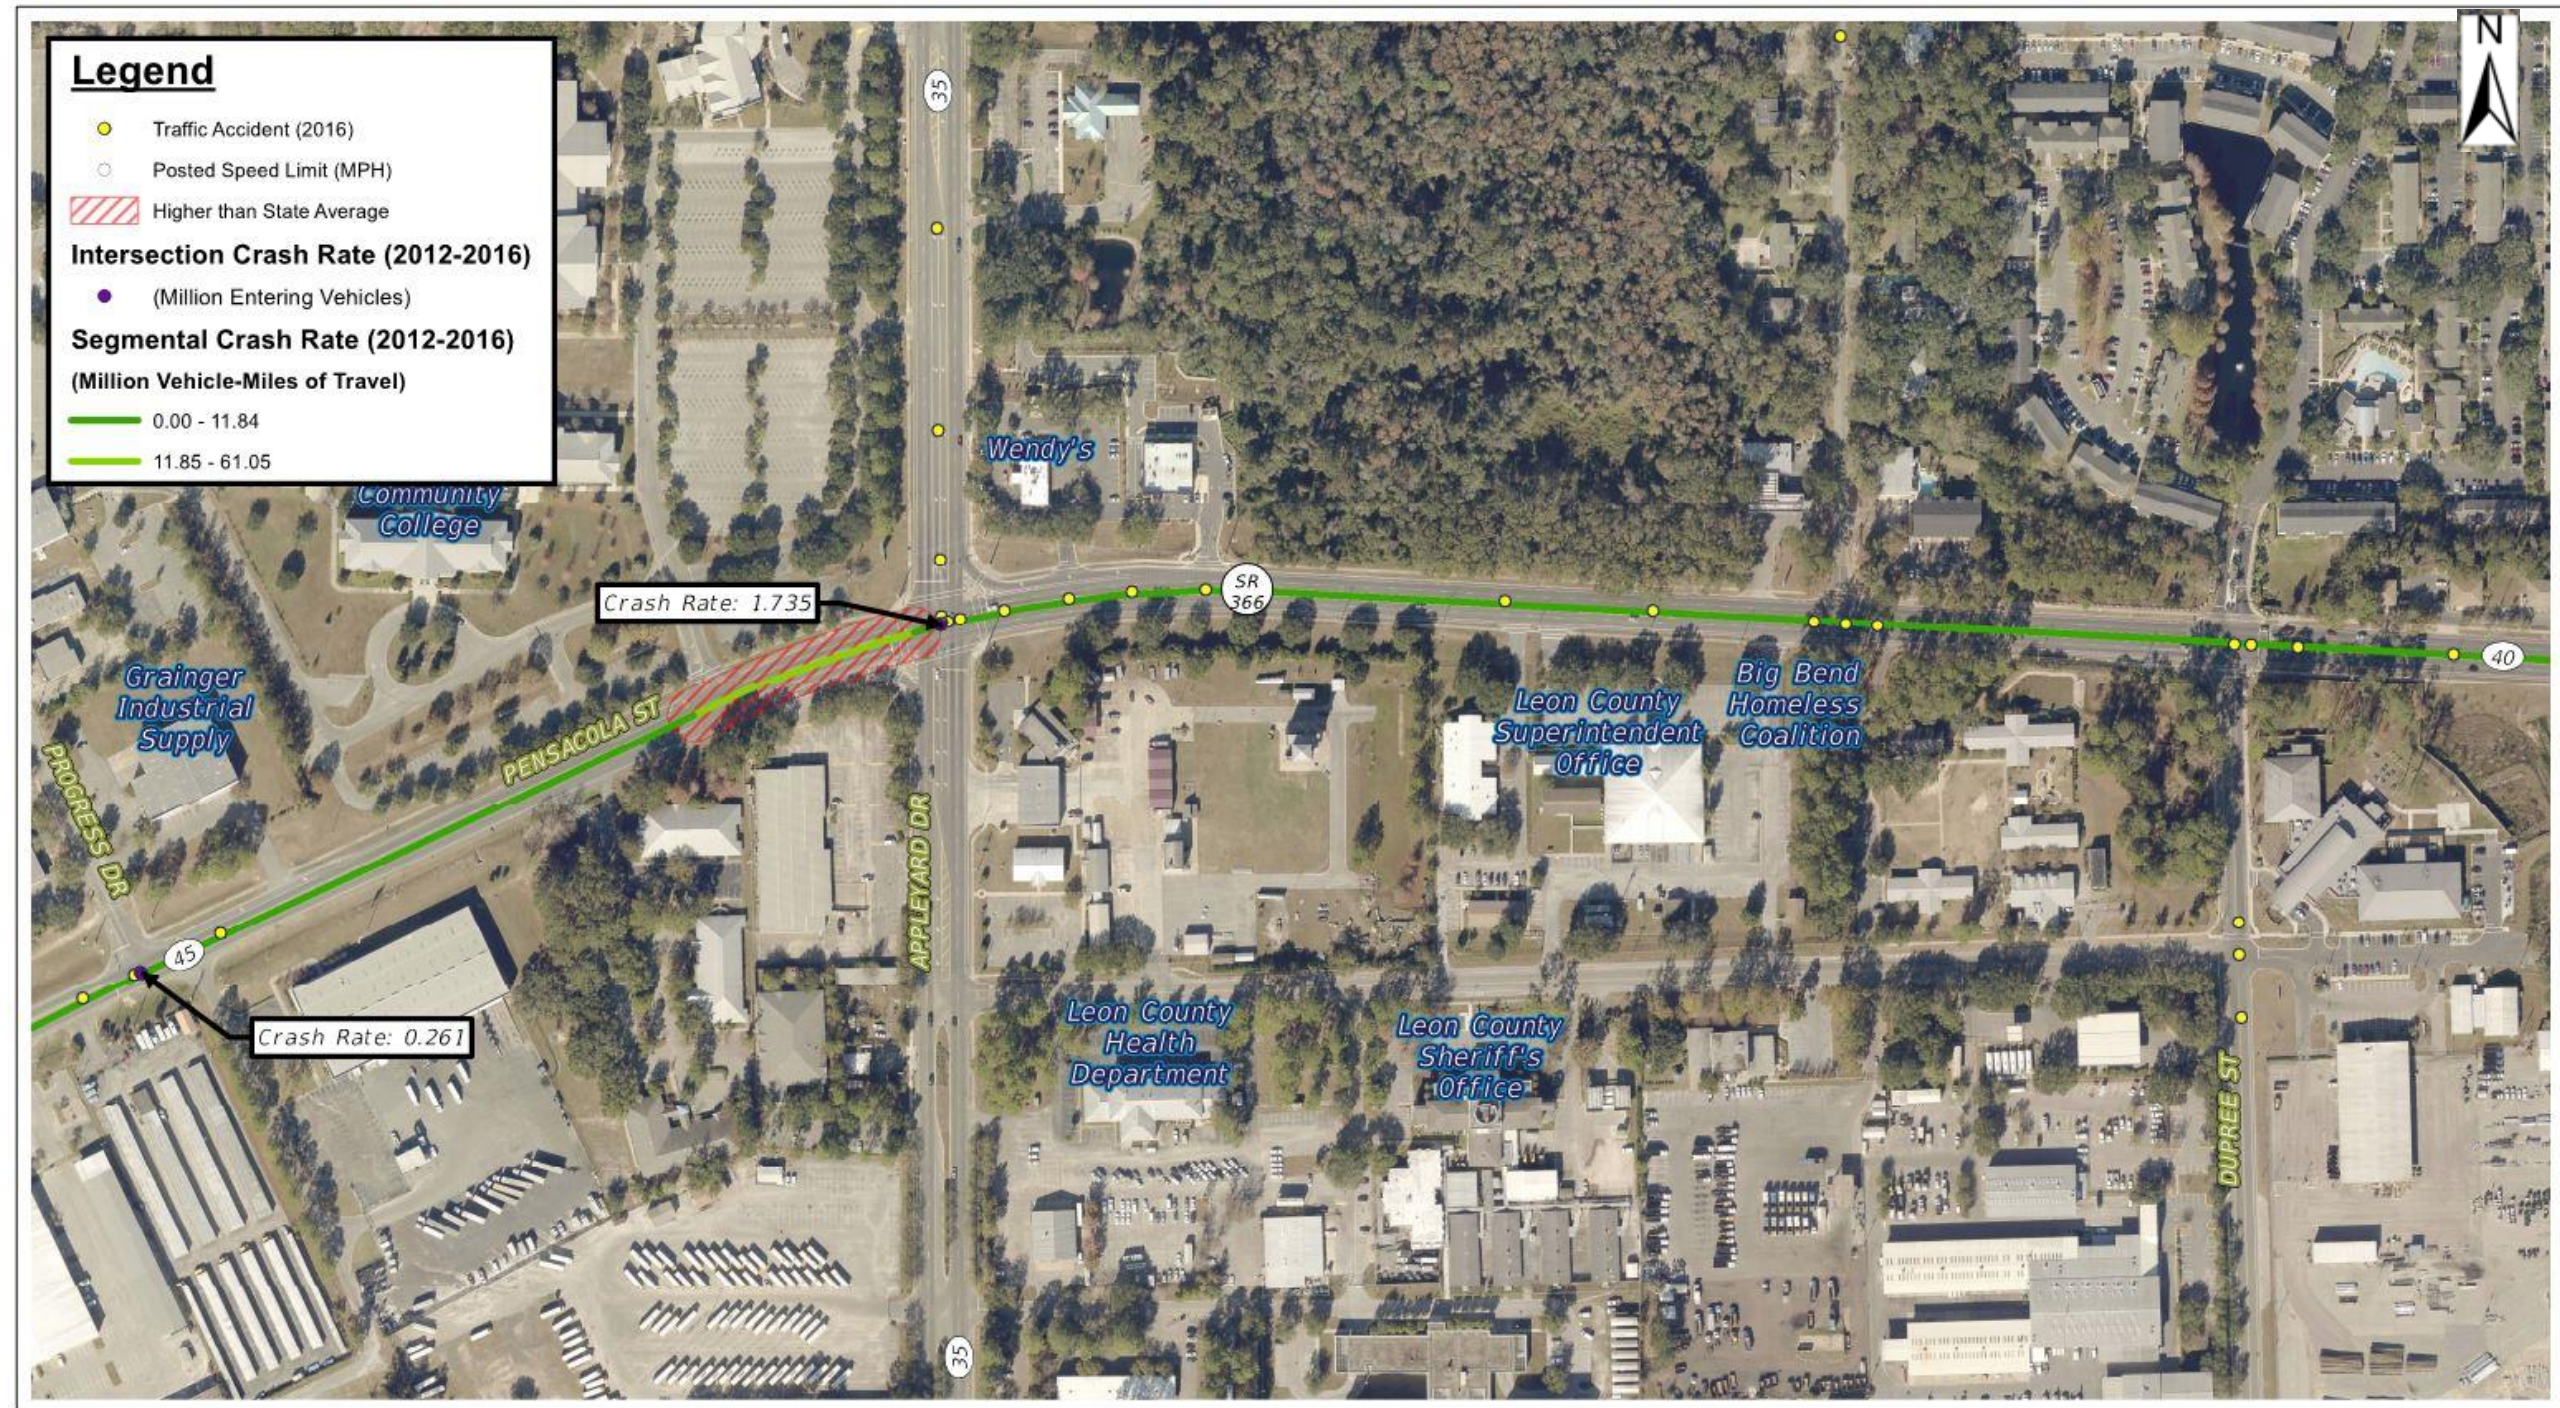
Figure 6. Highest Reported Crash Rate Along Pensacola Street

As described in **Figure 6**, the highest incidence of crashes occurs at the existing two-way access point near the intersection at Appleyard Dr. Managing access and reducing illegal movements will contribute to improved safety conditions along the corridor.

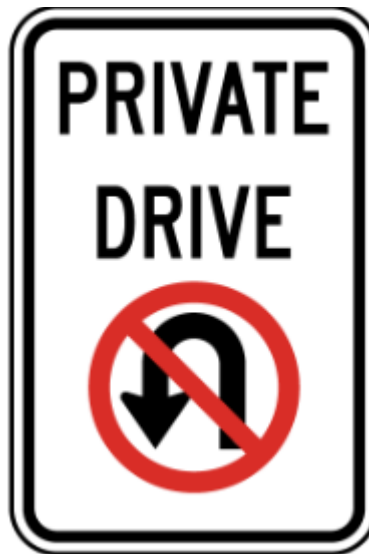
Figure 9. Proposed No U-Turn Sign

As a low-cost alternative to address one of these unadvised movements, the addition of signage may deter a portion of motorists (see **Figure 9**). With the consent of all parties, a "Private Drive, No U-Turn" sign is proposed to be placed at the entrance(s) of Disc Village, Grainger, and/or Pepsico.

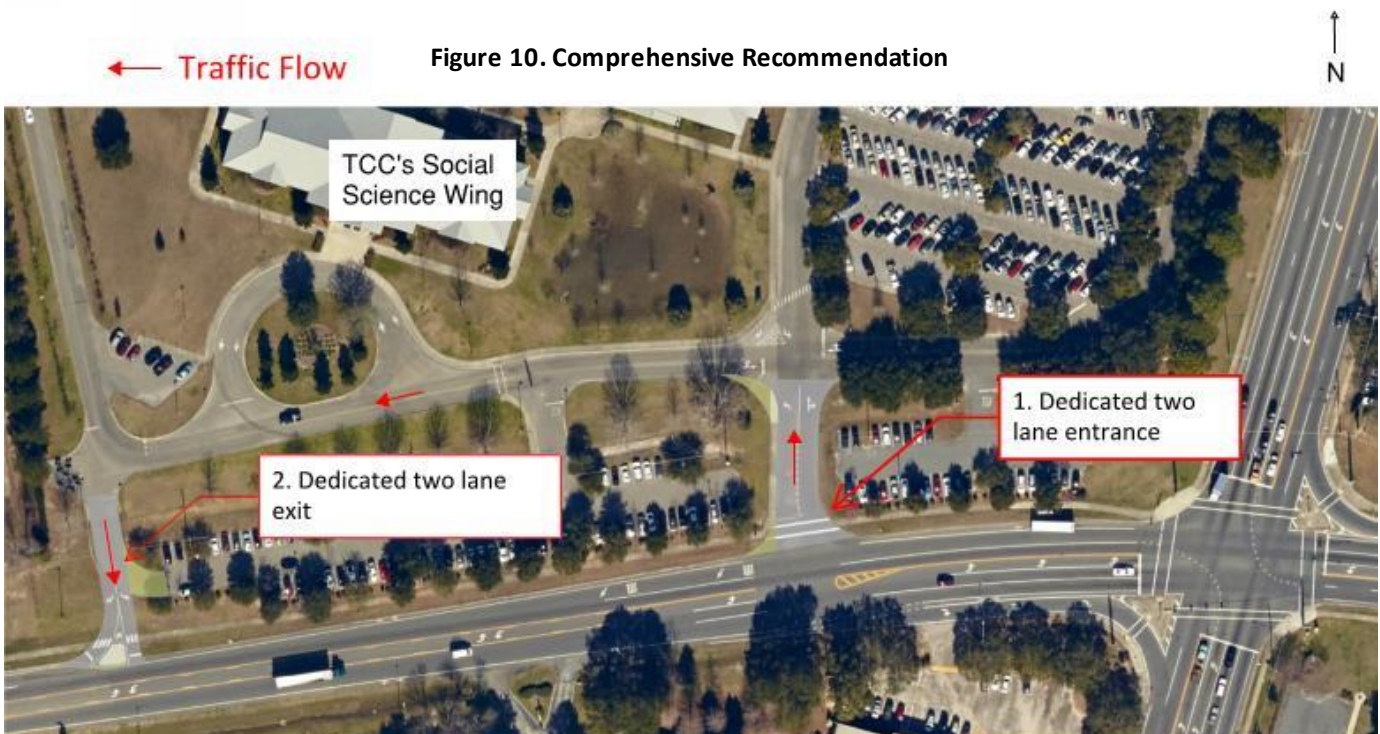
A more comprehensive solution to the issues described above involves reconfiguring the points of access to TCC from Pensacola. The first element of the proposed scheme involves creating a dedicated two lane entrance for TCC. The entrance will be restriped to create both a left turn and right through lane.

A second element involves the addition of a two-lane dedicated exit -- southwest of the Social Science Wing of TCC (see **Figure 10**). Locating this access further upstream from the Pensacola/Appleyard intersection allows motorists to safely make left turns eastward without affecting the queue and increasing the site distance of oncoming traffic. Minor striping changes, depicted below, will need to take place in order to guide motorists in a seamless fashion. Additionally, "Do Not Enter" signs will be warranted at the heads of the one way pair to alert drivers who may be unaware of the scheme.
