**Additional Information for Budget
Discussion Item #5
for Budget Workshop
June 21, 2022**

SUBJECT: Additional Information Requested on the Lake Hall School House

RE: Feasibility Study for the Relocation of The Lake Hall School

Existing Conditions Report

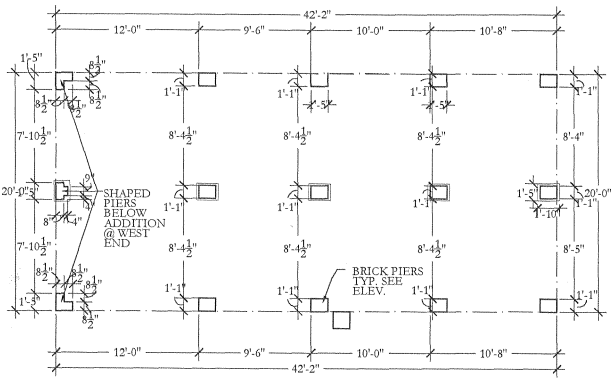
FOUNDATION PLAN
SCALE: 1/8" = 1'-0"

The foundations under the original school frame are typical friction type piers, a stack of interlaced running bond brick masonry 17" square (including masonry joints) with the exception of the three piers at the west end of the structure. These three are shaped piers, designed to accept the extended ends of the additions foundation beams. The north and south piers are 'L'-shaped and the center pier is 'T'-shaped.

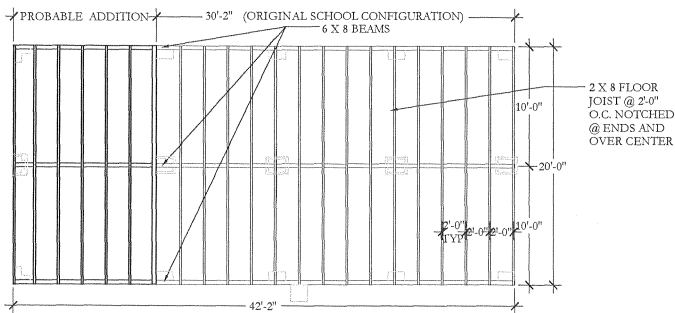
FRAMING PLAN
SCALE: 1/8" = 1'-0"

Balloon framing allows for ease of construction and economy of material and stabilizes a tall wall where there is no horizontal structure at the level of the top plate
